# **FIJI ELECTRICITY AUTHORITY TENDER DOCUMENT**

## **Addendum # 1**

**TENDER NUMBER: MR232/2017**

**TENDER NAME: Rust Treatment and Refurbishment of  
Communication Towers**

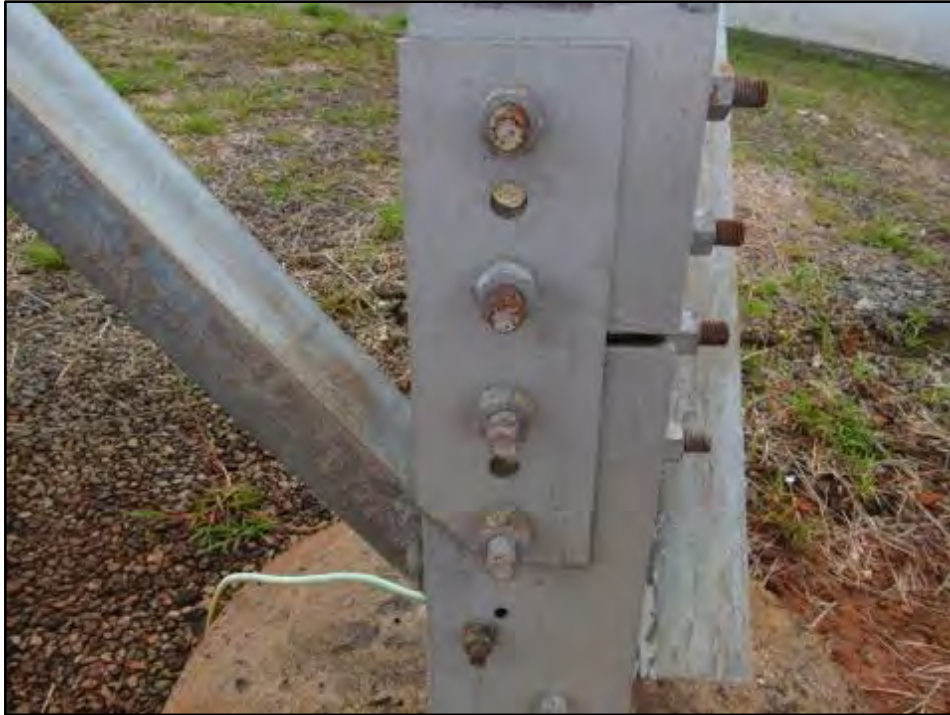
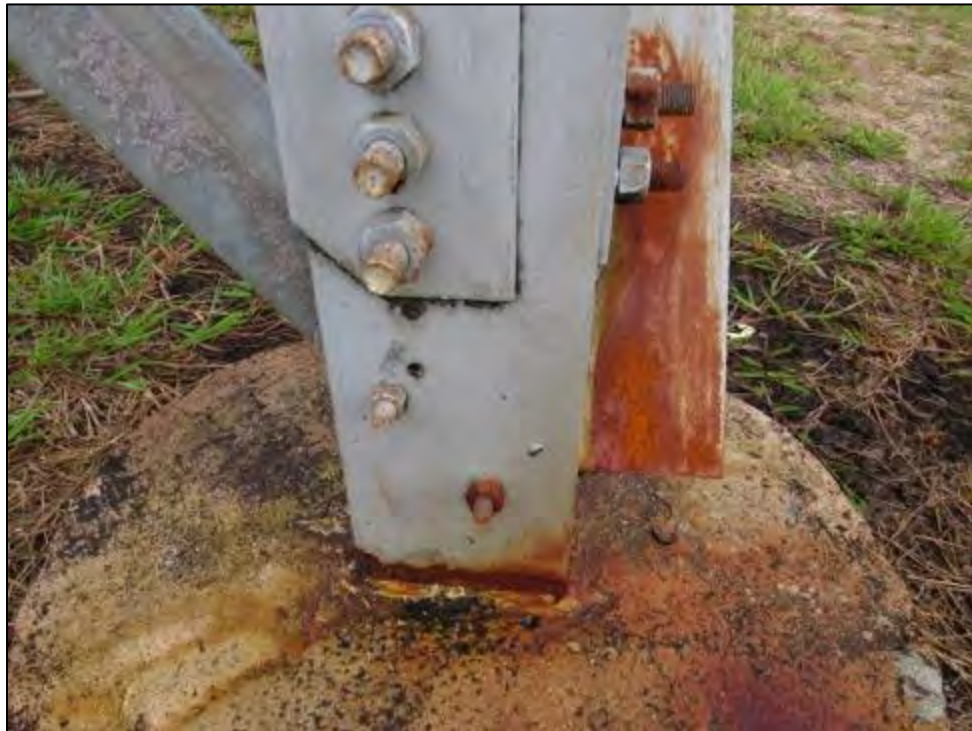
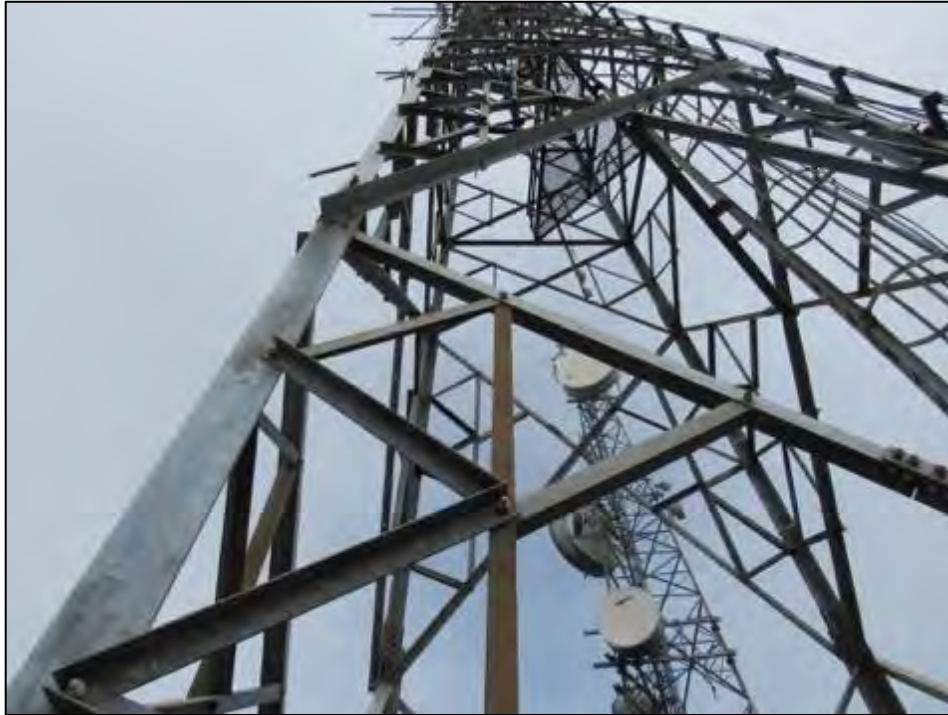
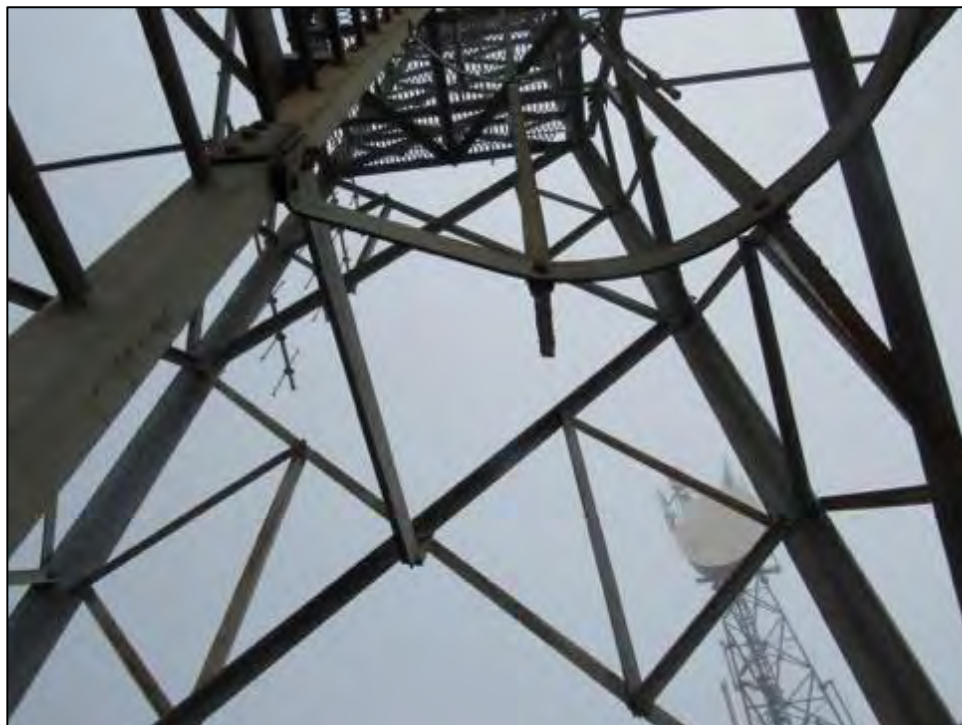
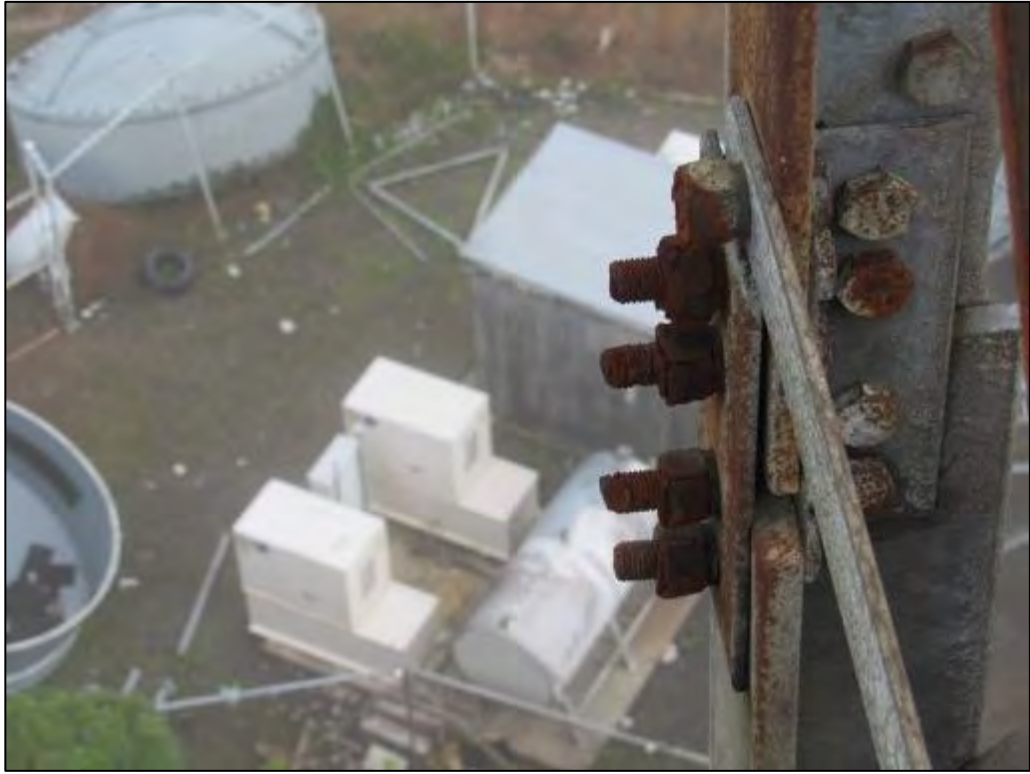
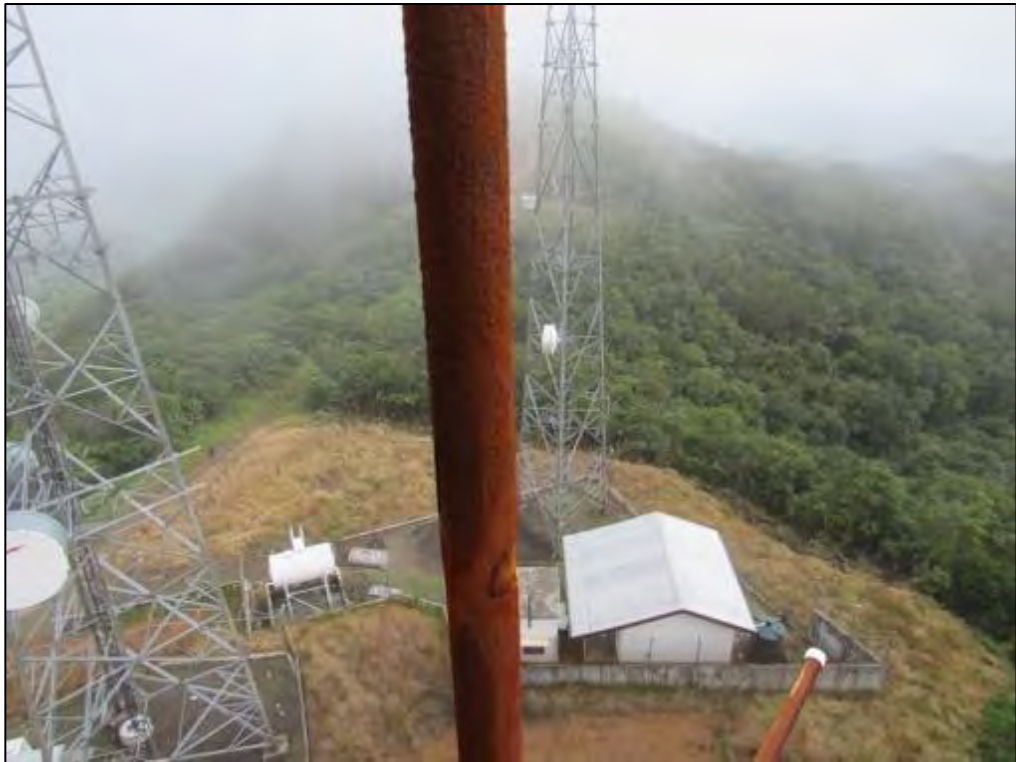
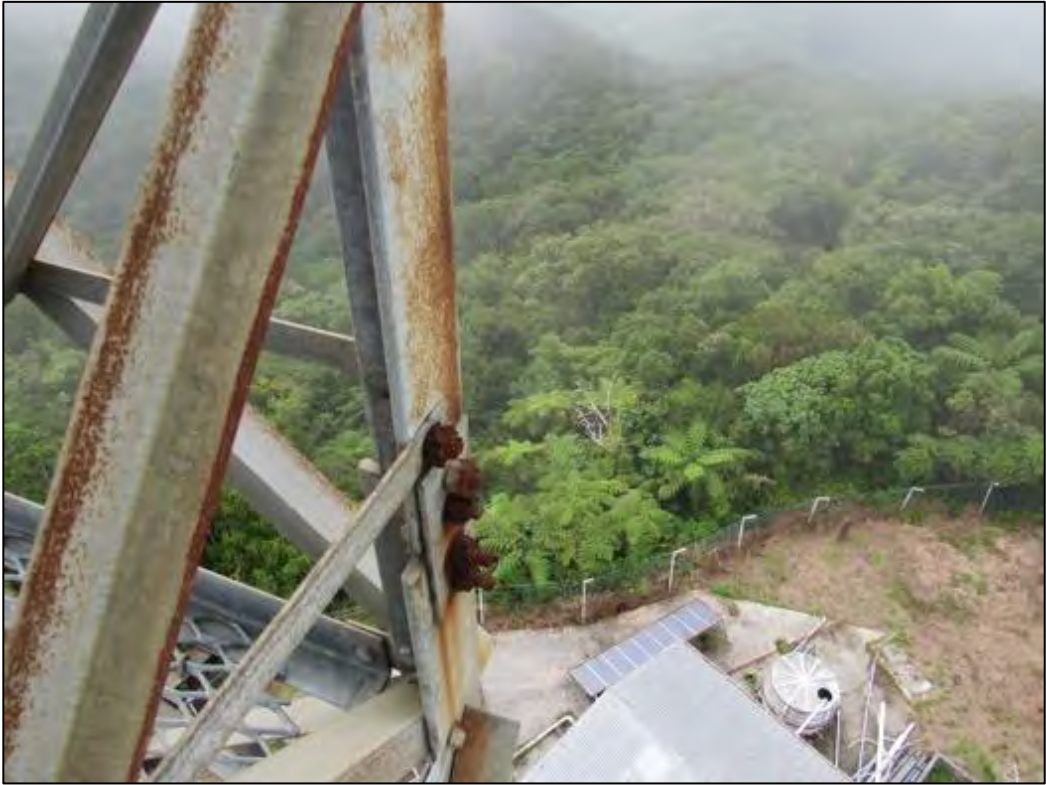
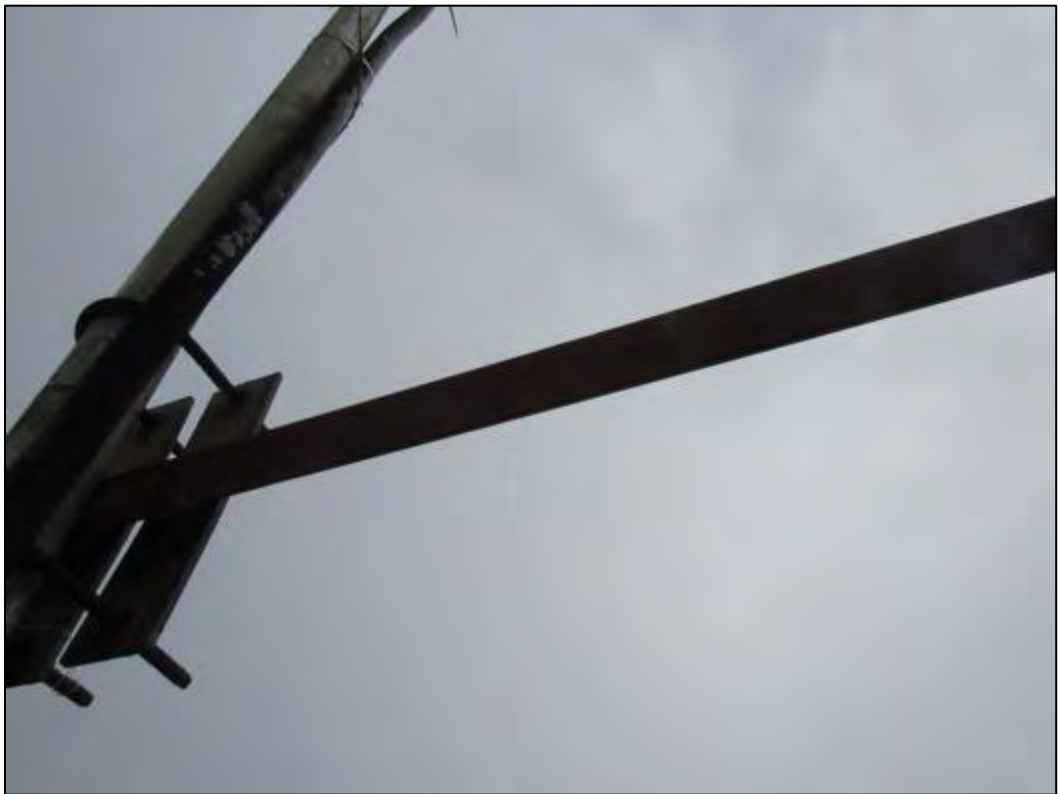
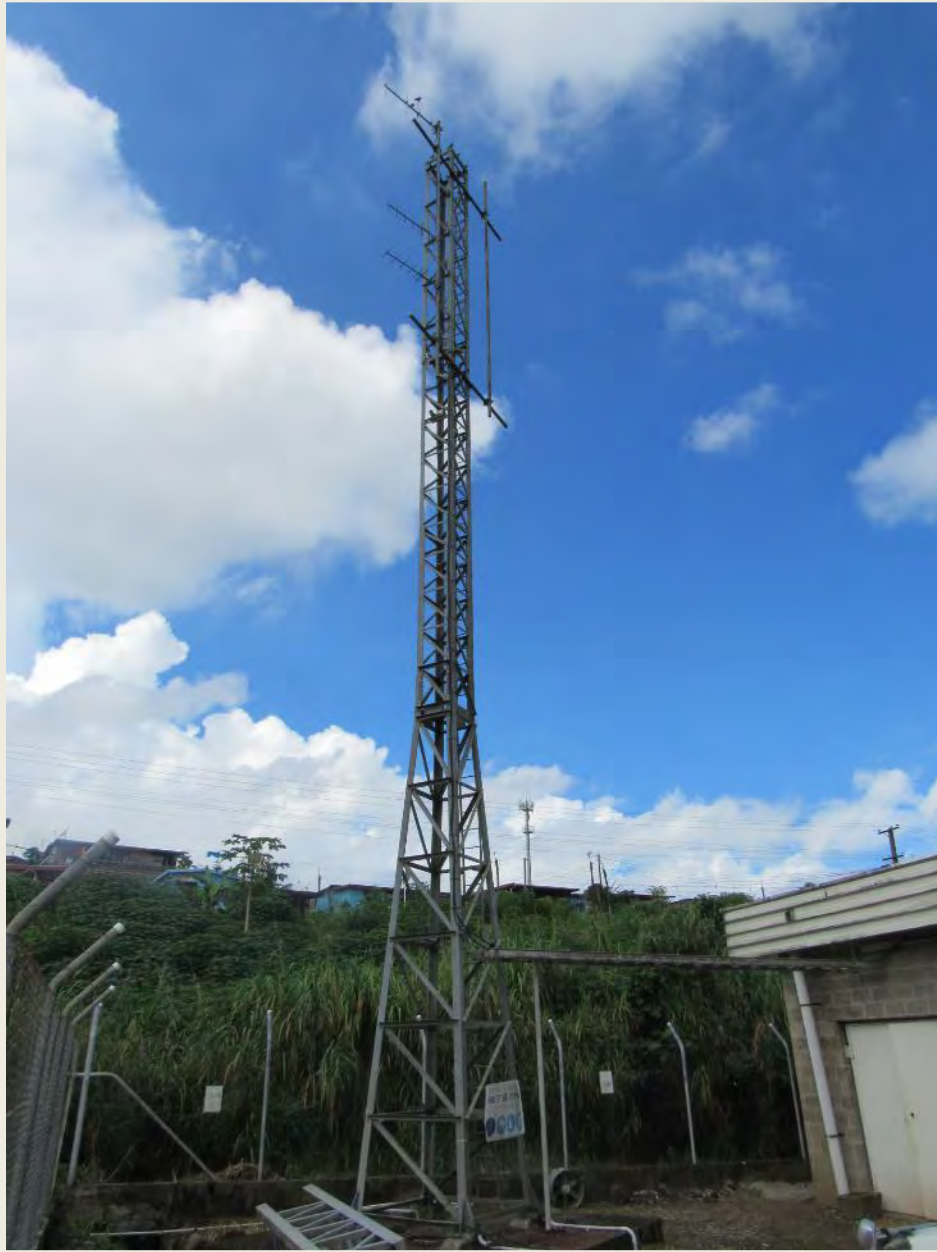
## Tower Images

Tim Greenhill and Wilson Nahi performed a condition assessment on the Delaikoro tower on the 20<sup>th</sup> June 2017. The tower is in a poor overall condition. The corrosion rapidly increases higher up in the structure due to sitting in fog. No R/C tower members at the date of inspection but this will increase in the future if not refurbished

500 R/C M16 bolts on tower 120 M24 bolts R/C some missing

First ladder platform loose and second ladder run the cage is R/C

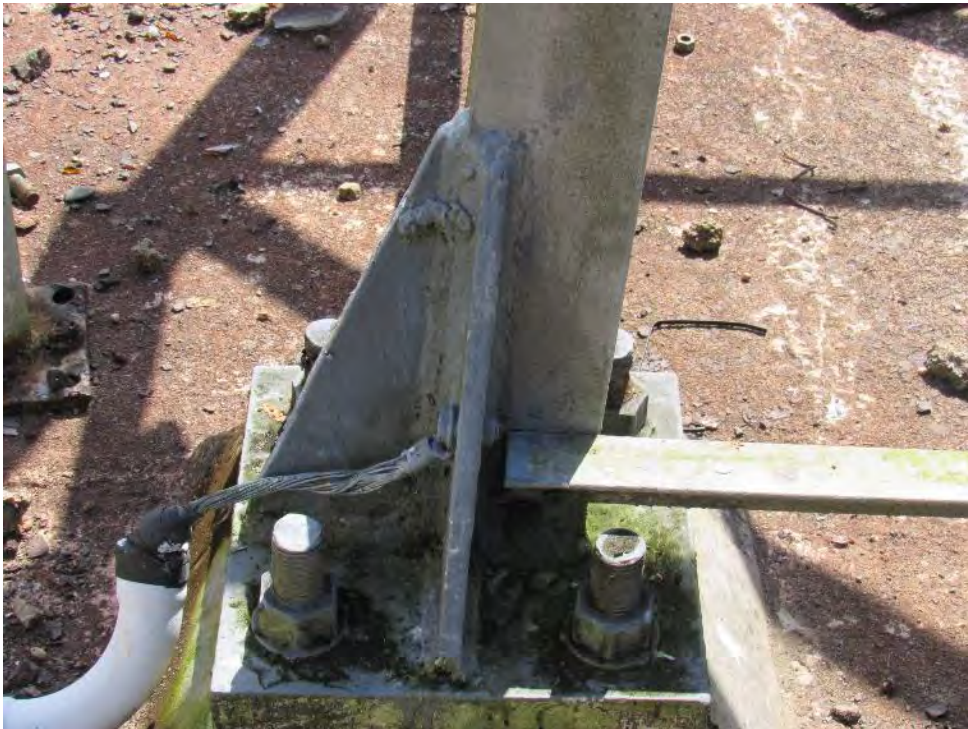
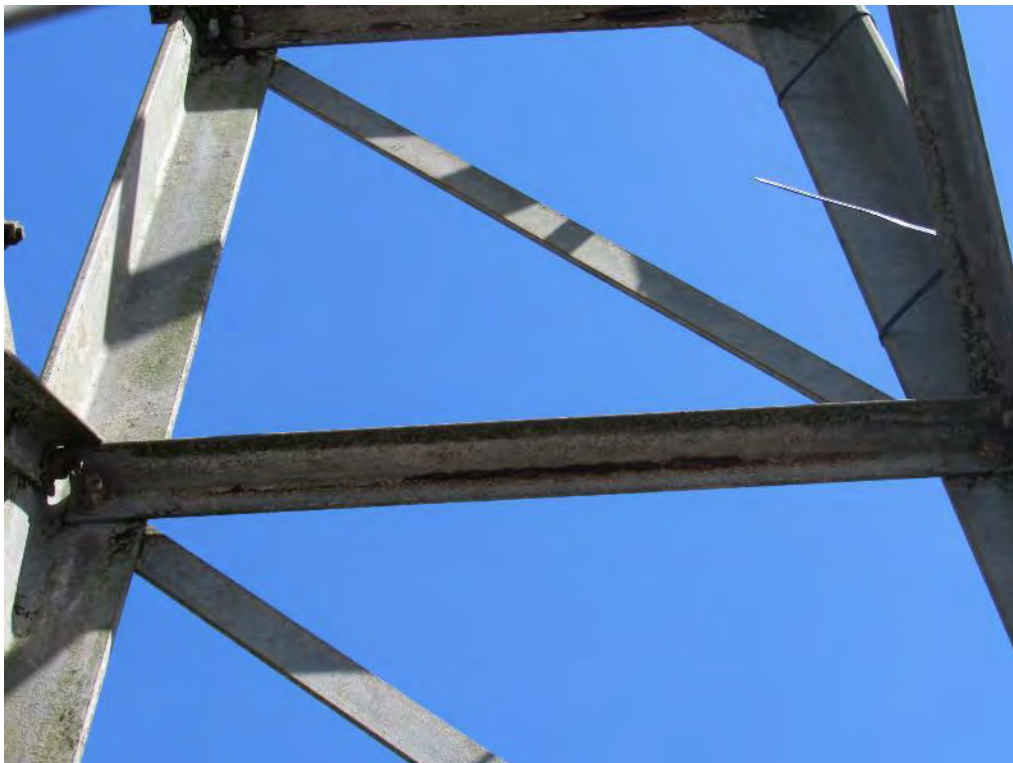
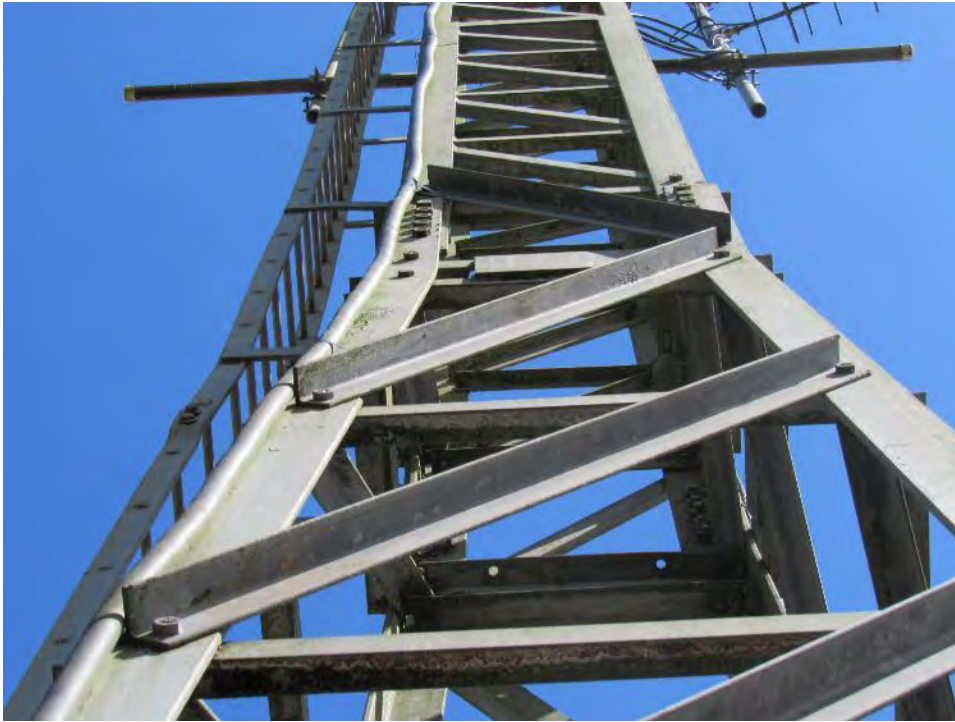
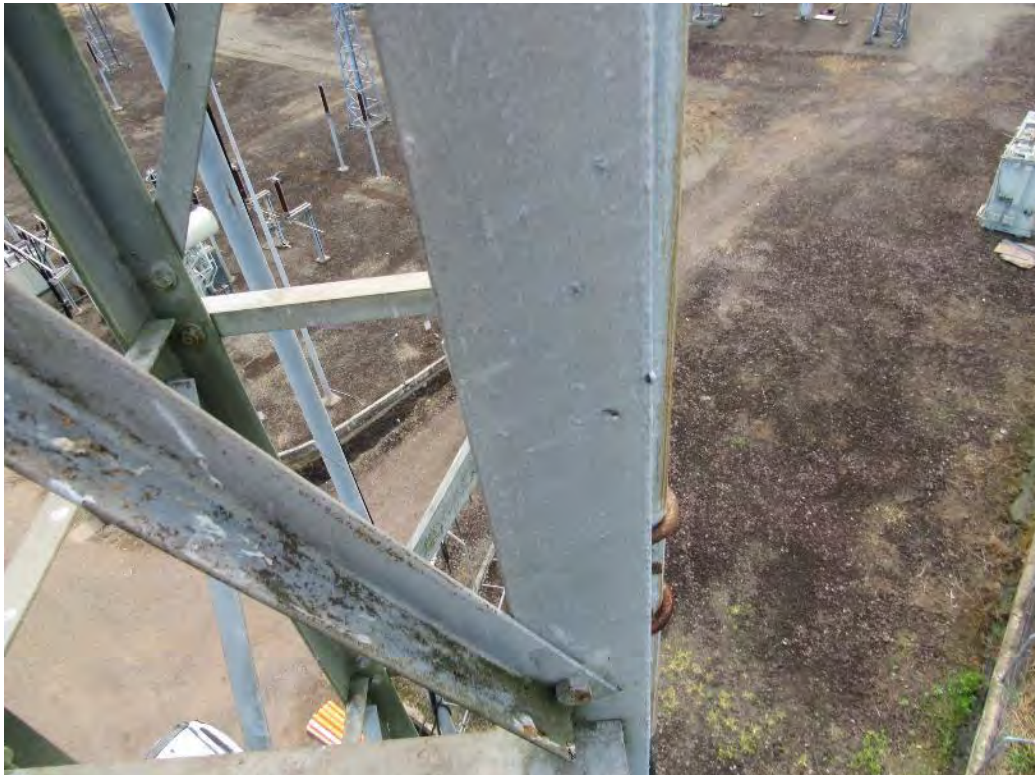
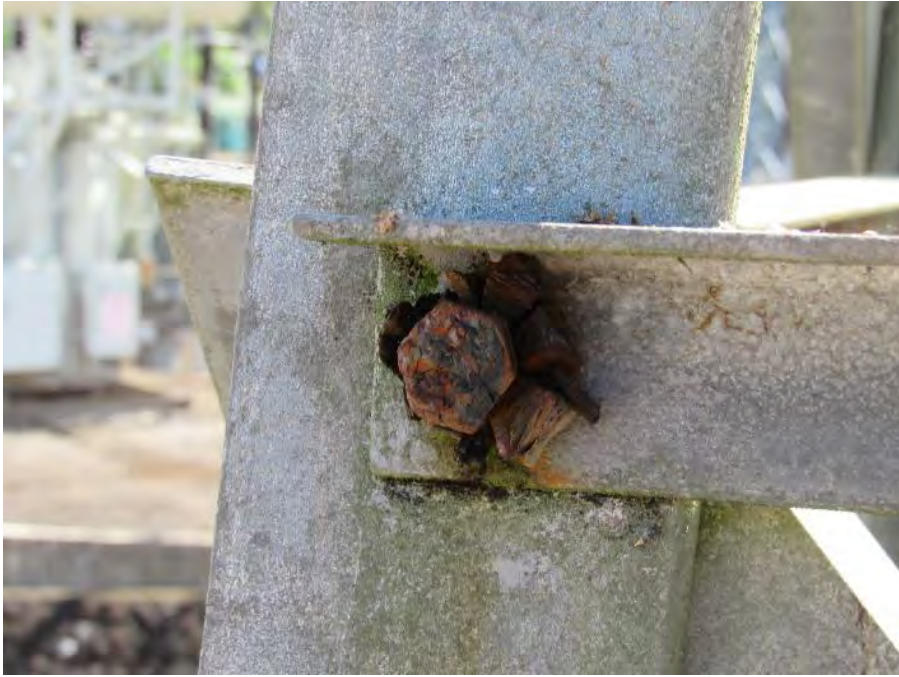
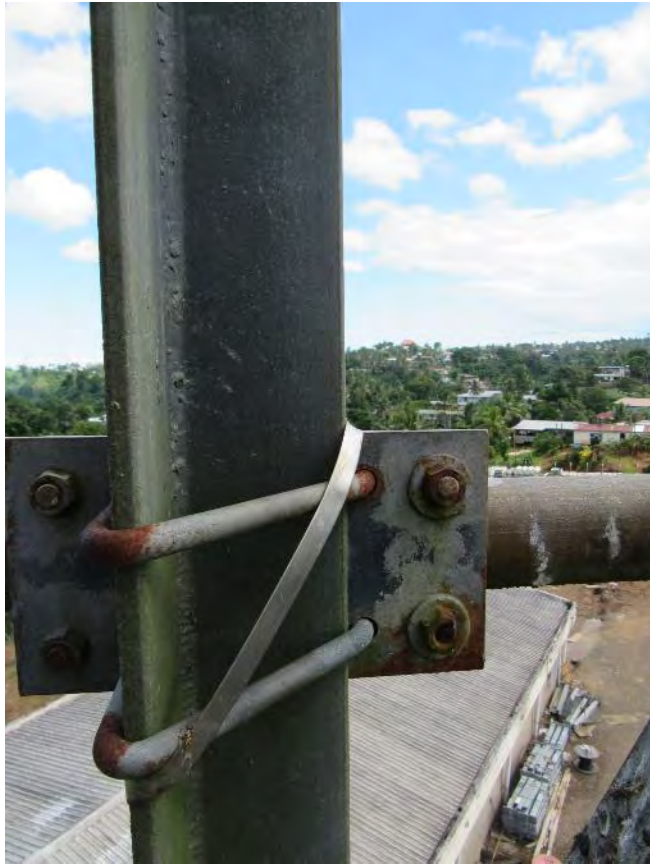
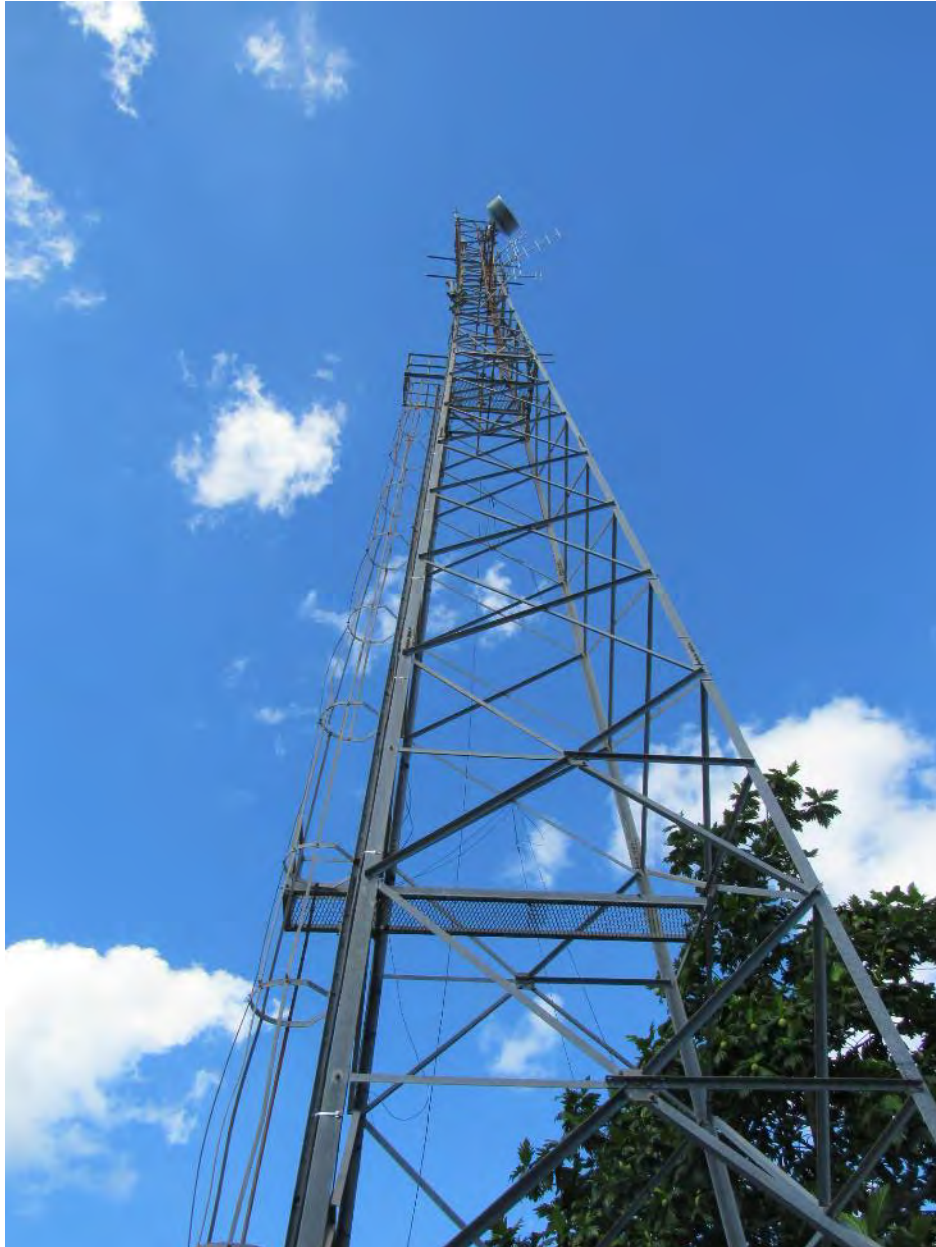
## Tower Images

The Condition assessment was carried out by Tim Greenhill on the 24 of April 2017. The first element to inspect was the structure foundations. It was noted that the horizontal closest to the ground is loose. It is noted that the structure is 18m tall

It was estimated that there were at least 40 M16 bolts that had reached replacement criteria.

During the assessment, 1 member was noted as having reached the point where replacement is required.

Overall, there was 40 % of the tower surface area that will require secondary preparation, ie abrasive blasting to remove the rust, whilst the remaining surfaces will only require pressure washing.

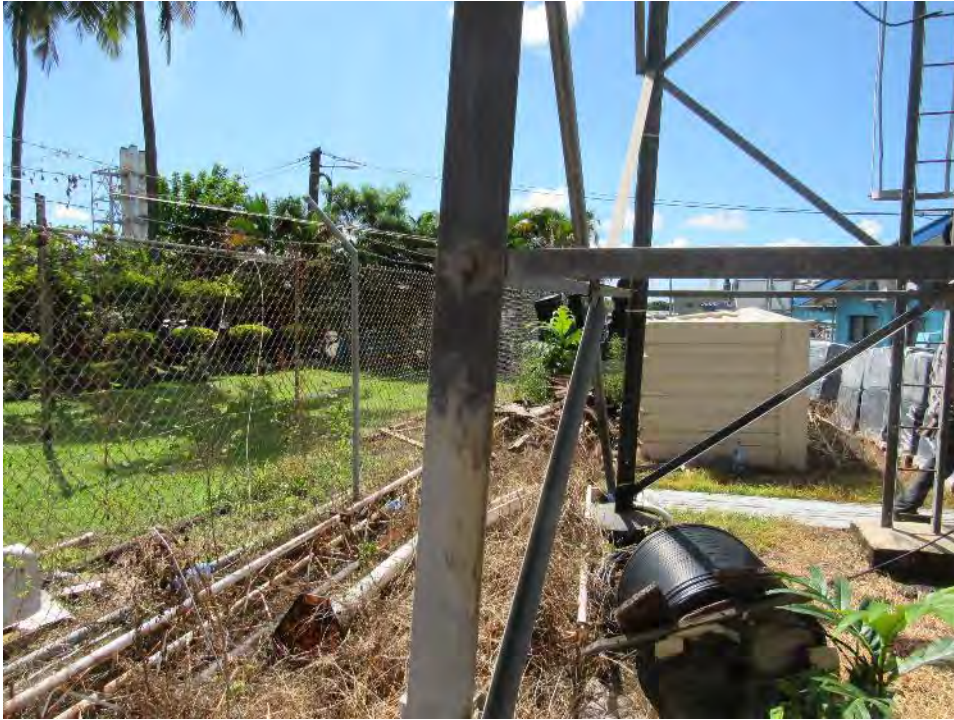
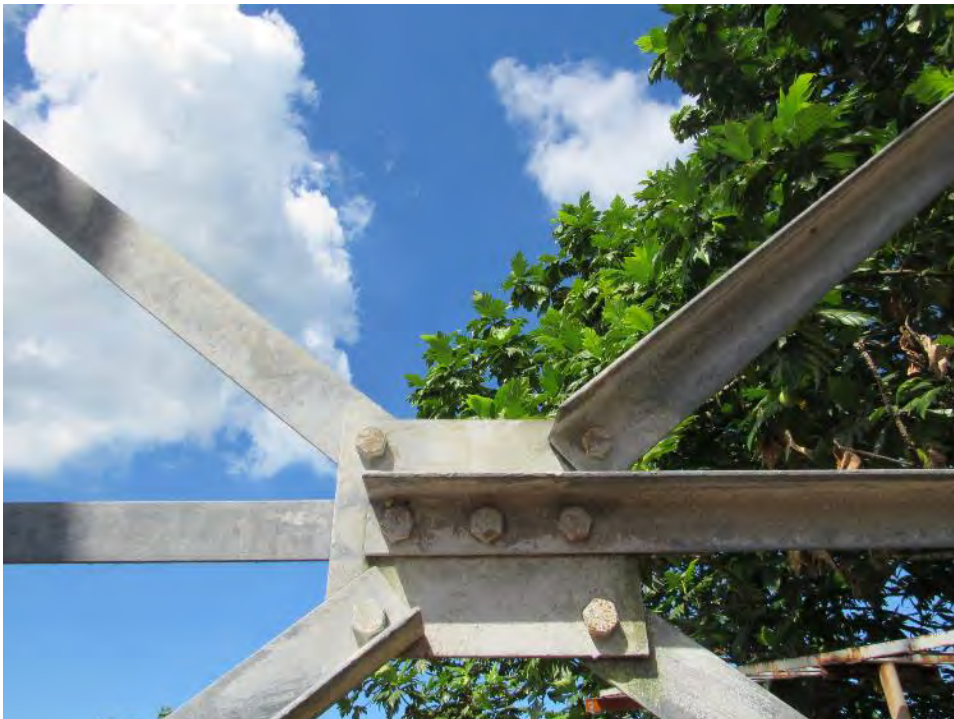
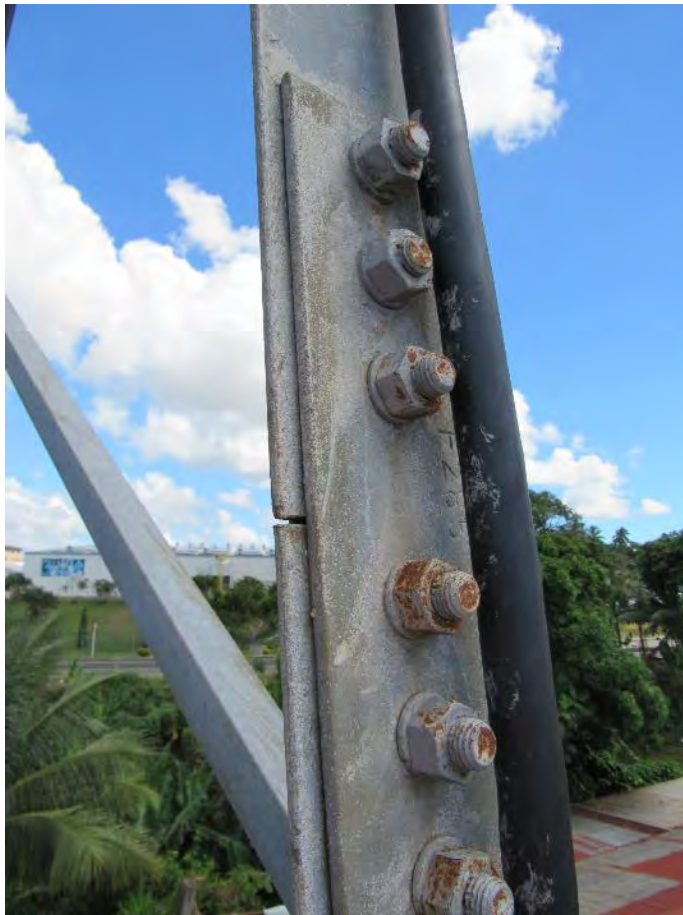
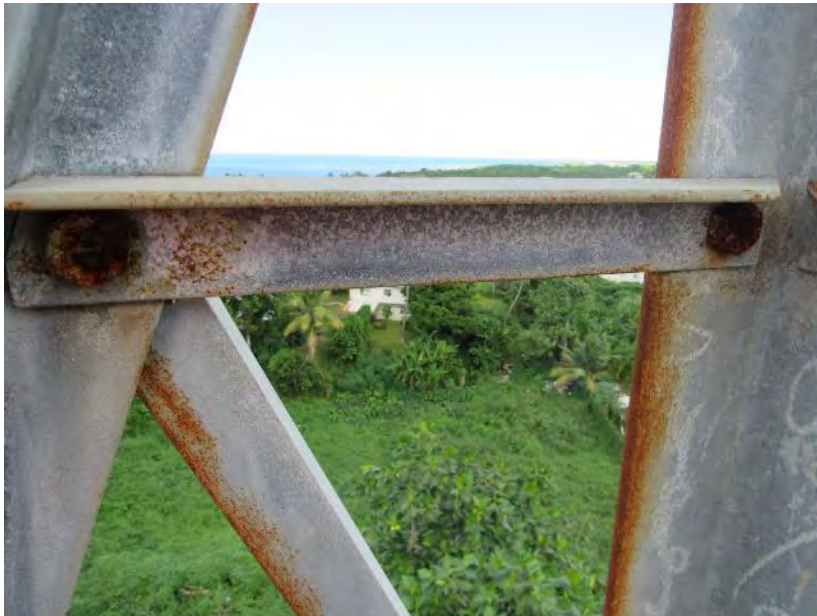
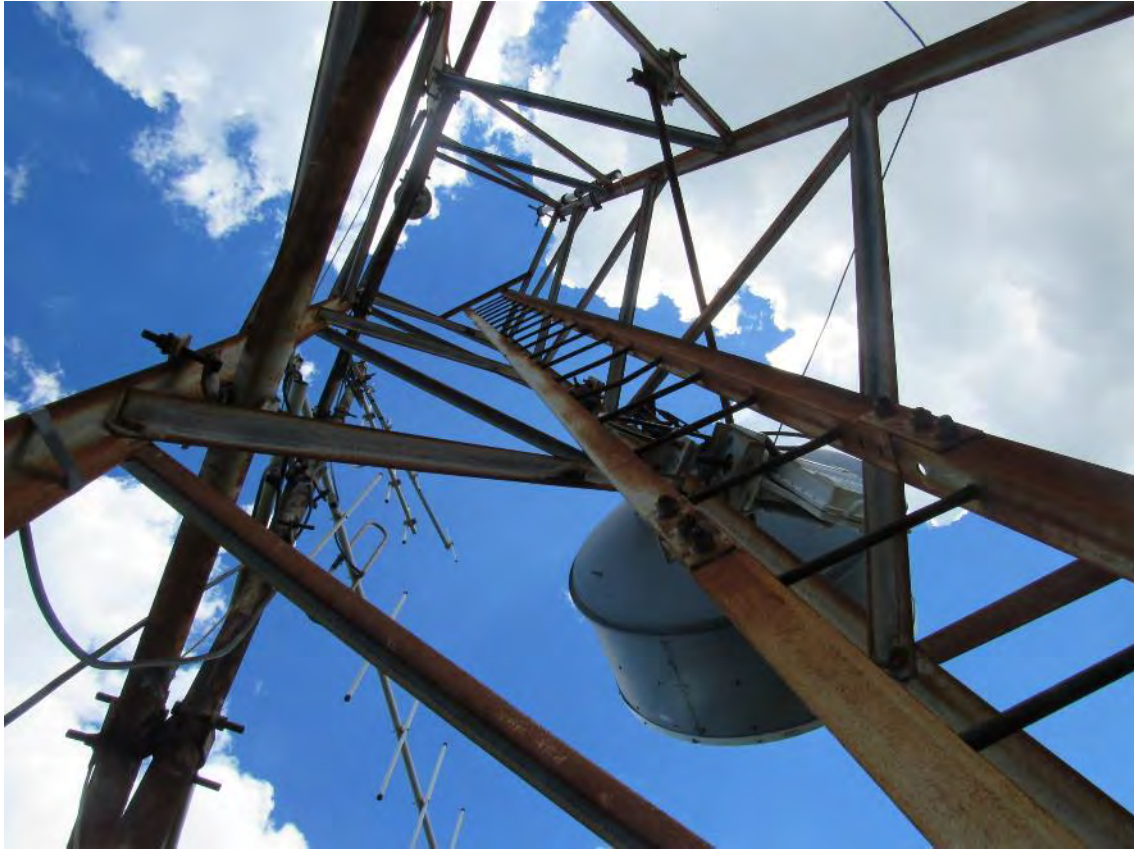
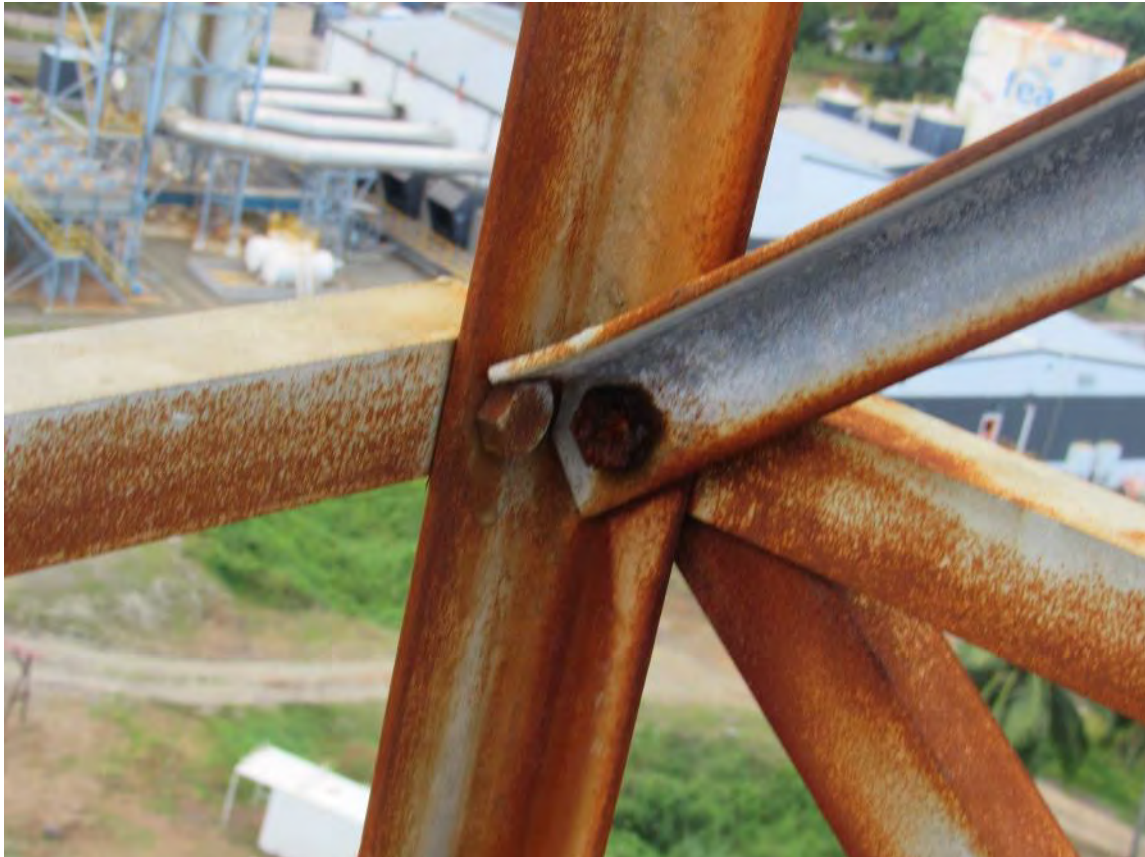
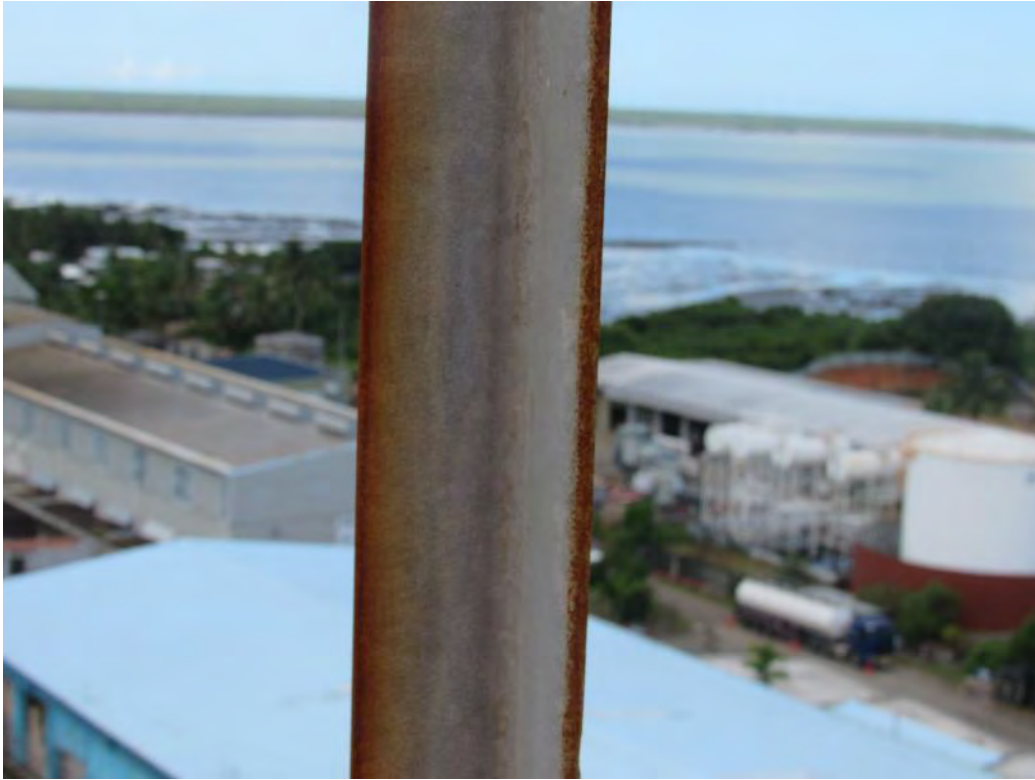
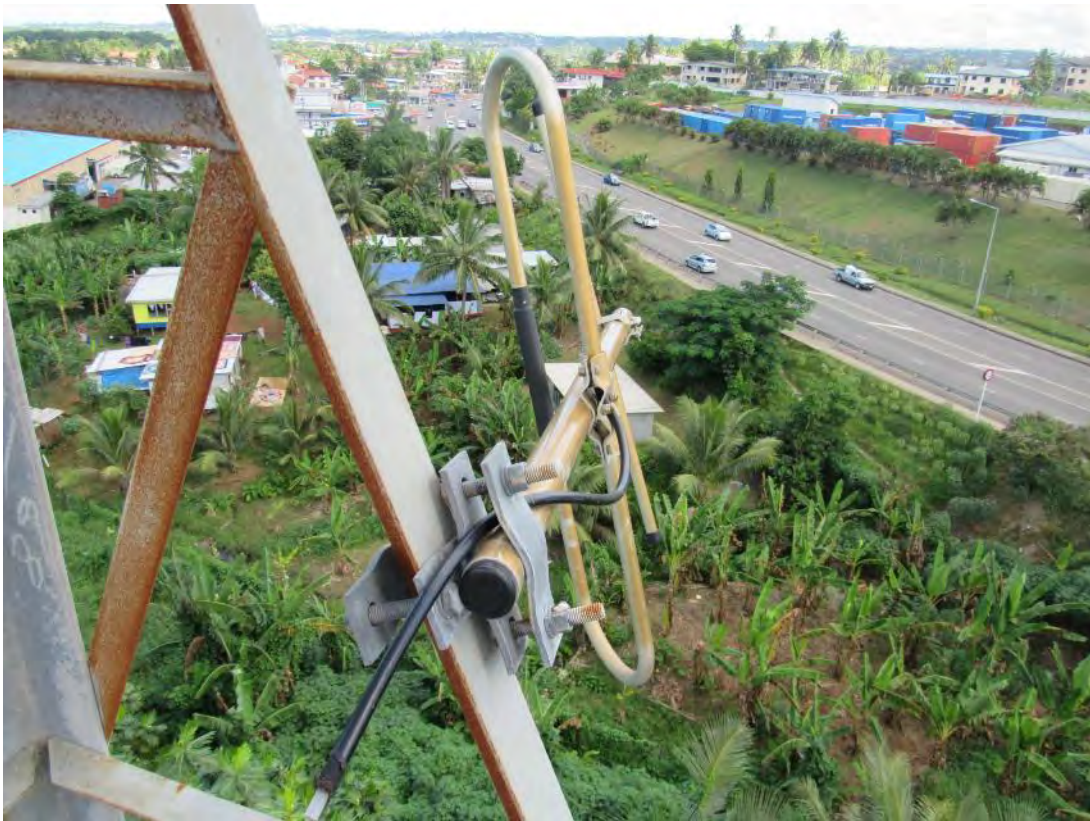
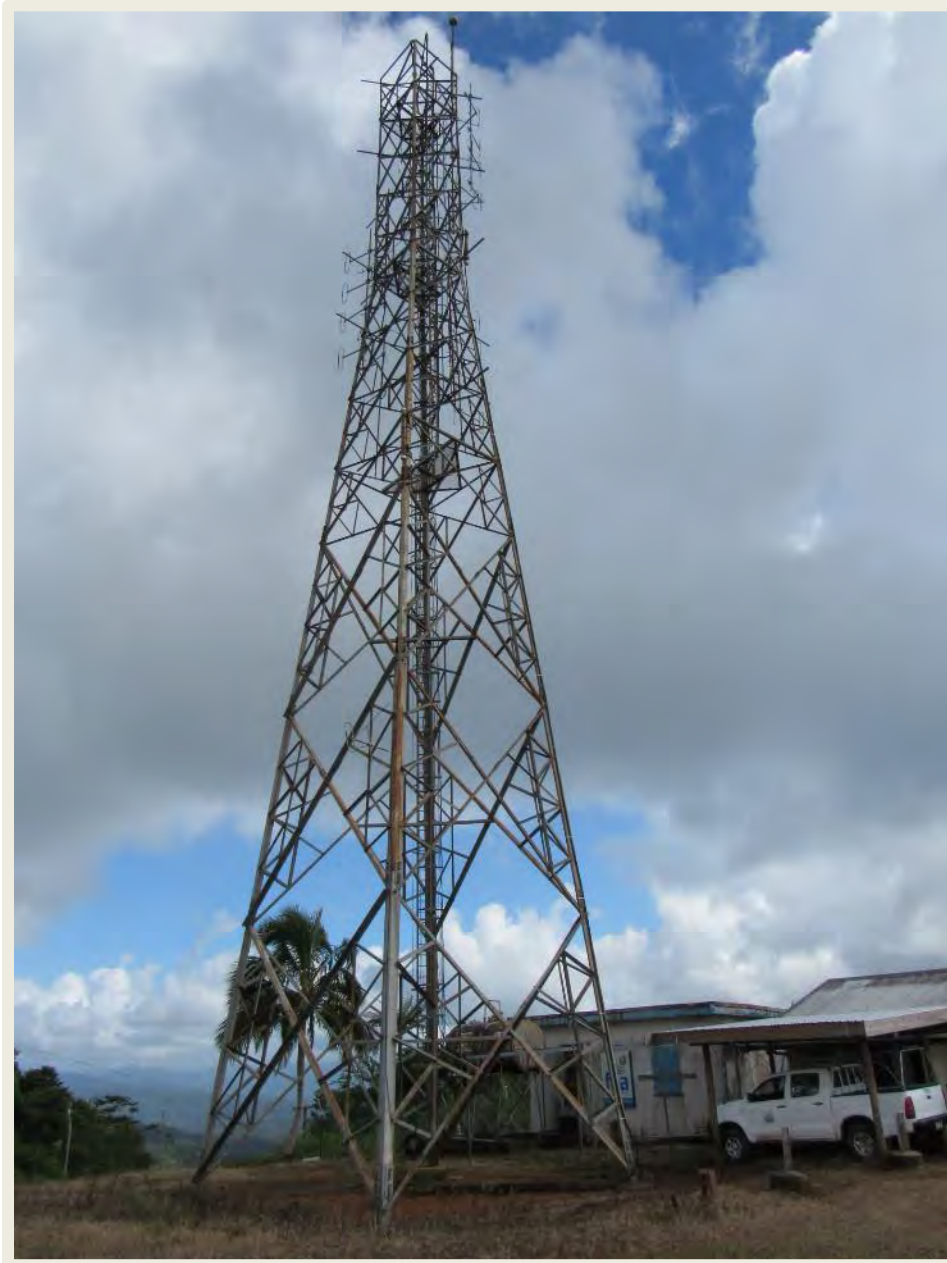
## Tower Images

The Condition assessment was carried out by Tim Greenhill on the 26 of April 2017. The first element to inspect was the structure foundations.

It was estimated that there were at least 250 M16 bolts that had reached replacement criteria.

The internal climbing ladder was unsafe, requiring approximately 100 m12 bolts replaced to make it safe to use.

During the assessment over 40 members were noted as having reached the point where replacement is required.

Overall, there was 60 % of the tower surface area that will require secondary preparation, ie abrasive blasting, to remove the rust, whist the remaining surfaces will only require pressure washing.
