# **FIJI ELECTRICITY AUTHORITY TENDER DOCUMENT**

## **Addendum # 1**

**TENDER NUMBER: MR232/2017**

**TENDER NAME: Rust Treatment and Refurbishment of  
Communication Towers**

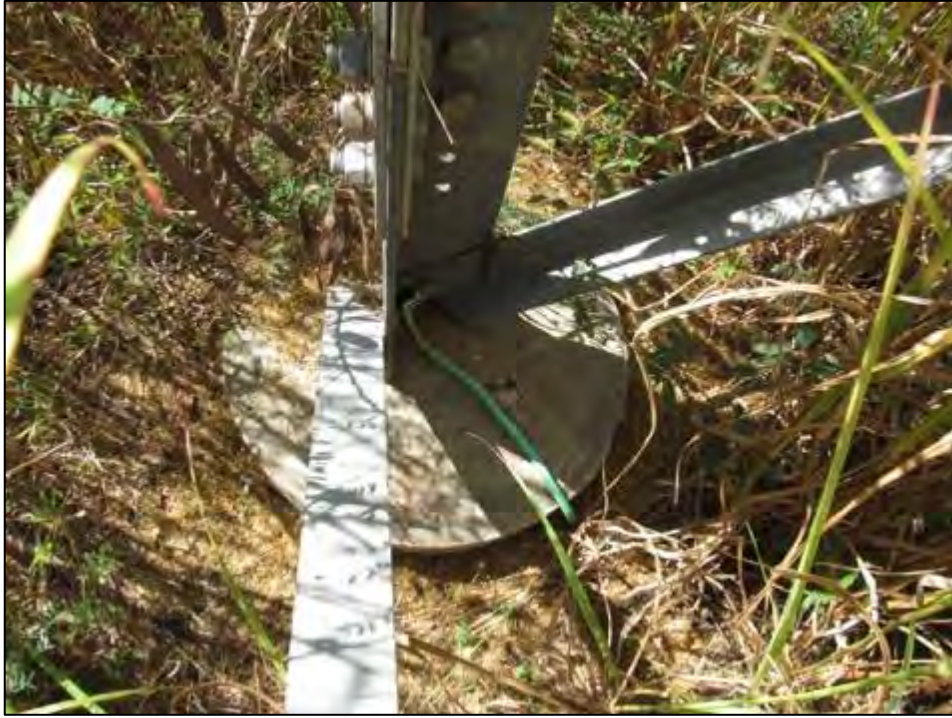
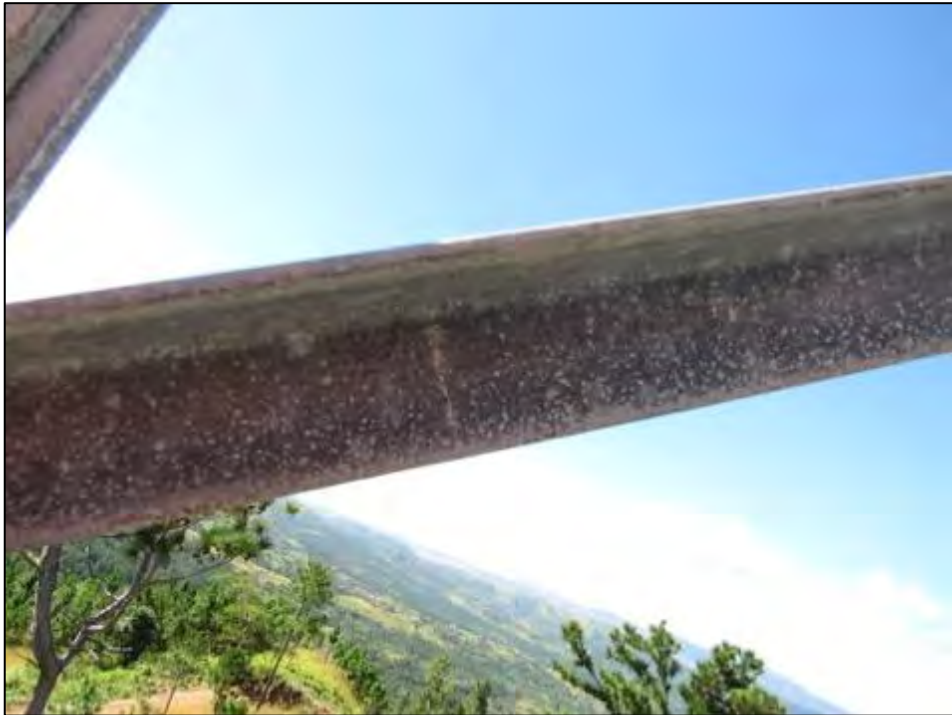
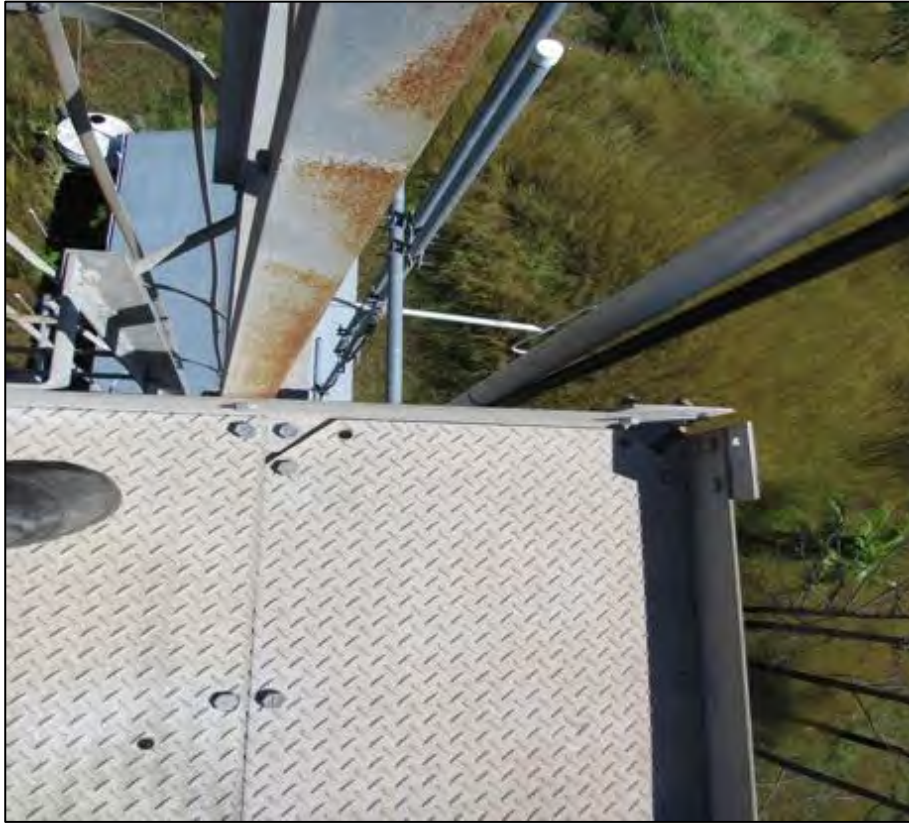
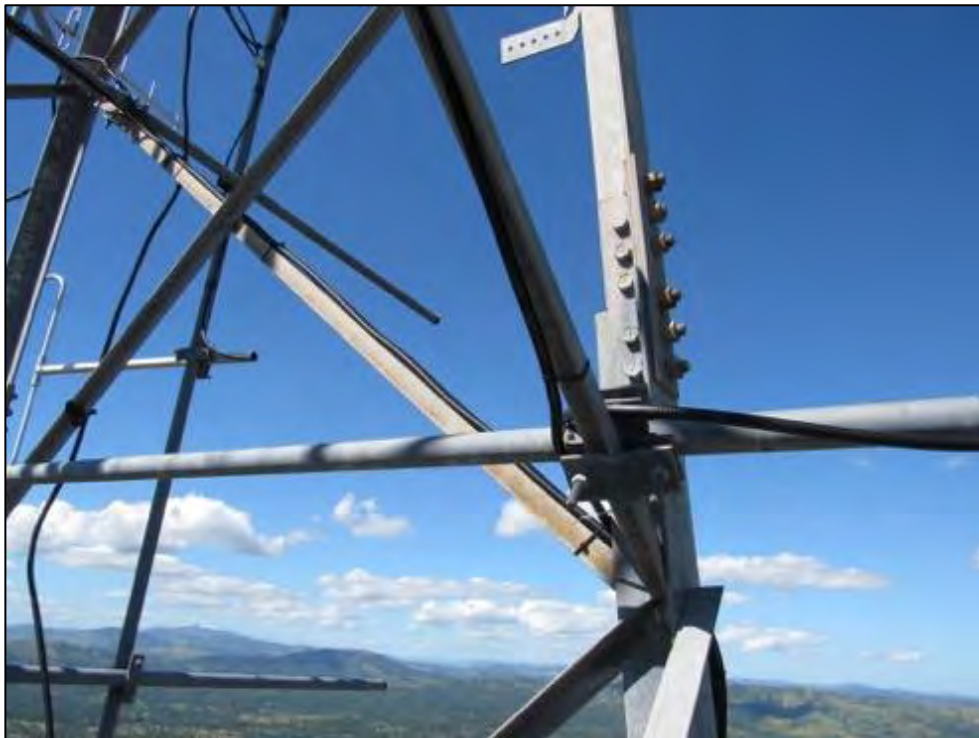
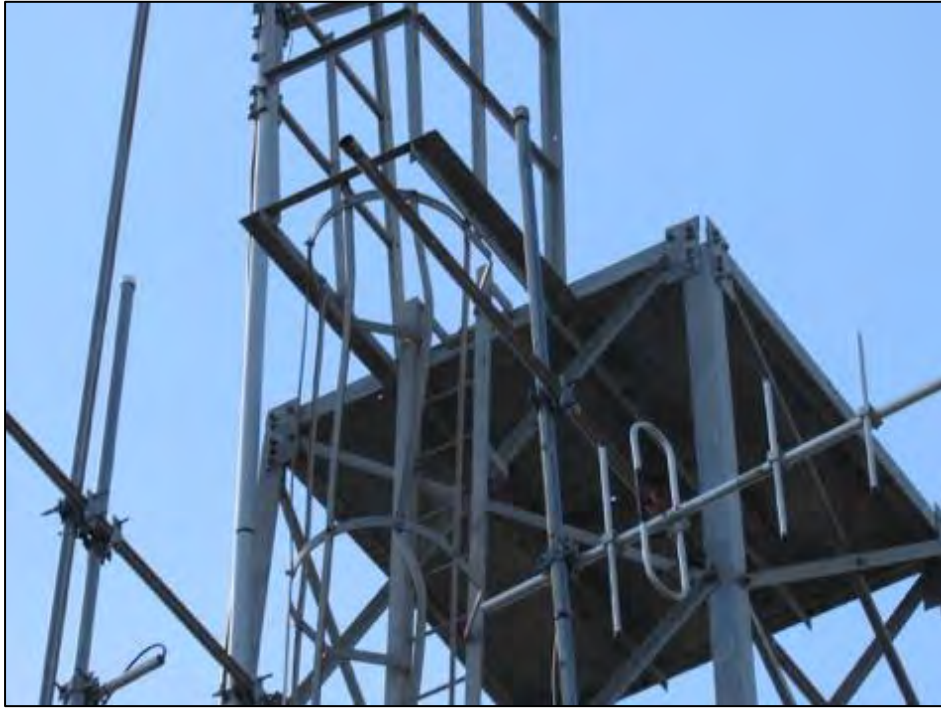
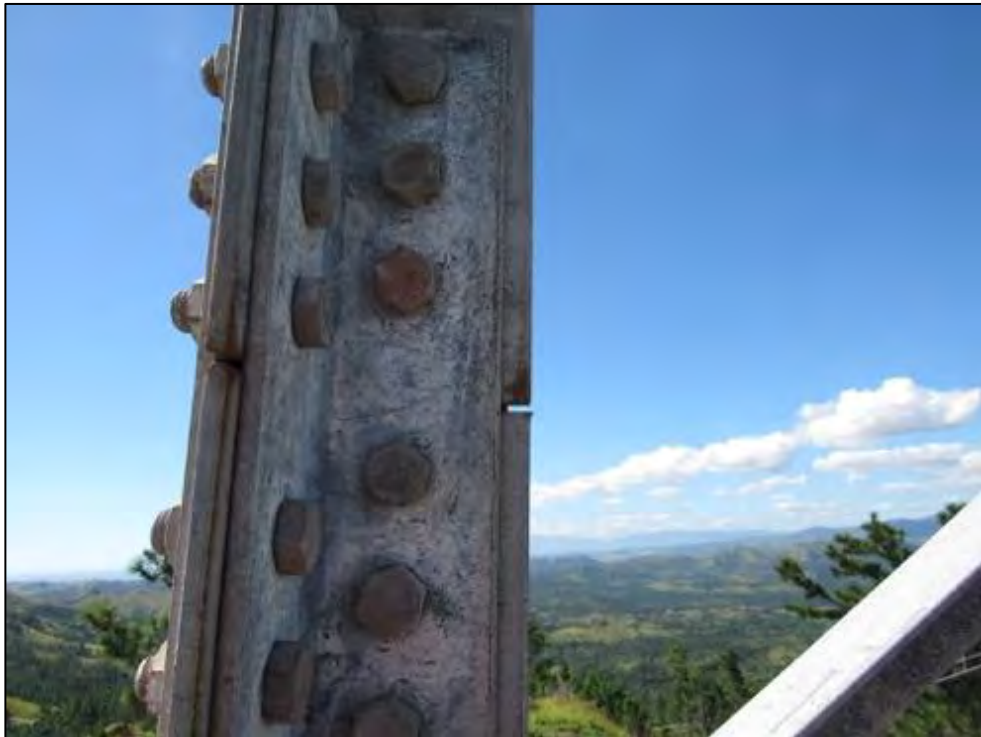
## Tower Images

A Condition assessment was carried out on the 26<sup>th</sup> May 2017 by Tim Greenhill and Wilson Nahi. Starting from the ground working their way up the tower, it was noted that the tower is in a good overall condition. The whole structure needs a bolt torquing as there some loose members. Rust break-out on bolts and nuts was noted. Two missing M16 bolts on 2<sup>nd</sup> level platform, and one bracket holding a UHF aerial meets replacement criteria. ZCP is starting to form on some of the edges of the steel members. Minor members higher up the structure have rust break-out forming.

The tower is currently in good condition. There are a number of indicators that the onset of degradation is not far away. Given that there is very little in the way of secondary preparation we would recommend that the tower be given a pressure wash, the localised areas of rust (approx. 10-12m<sup>2</sup>) be wet abrasive blasted and a suitable protective coating applied. The first coat over the blasted areas and a second coat over the entire structure. Consideration could be given to trialling of one of the water borne zinc rich paints<sup>1</sup> that are currently being offered by a number of manufacturers.

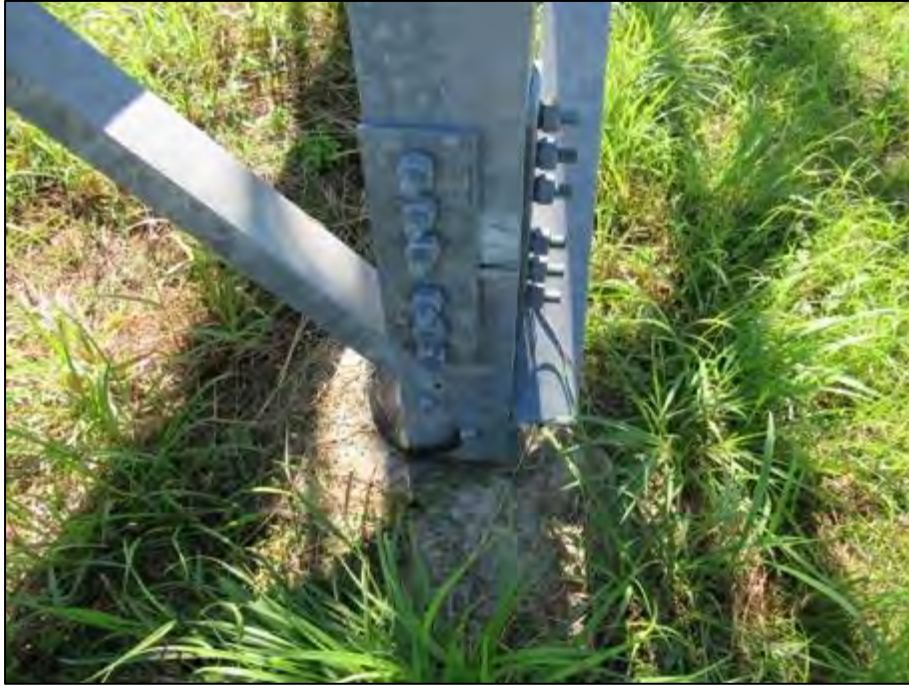
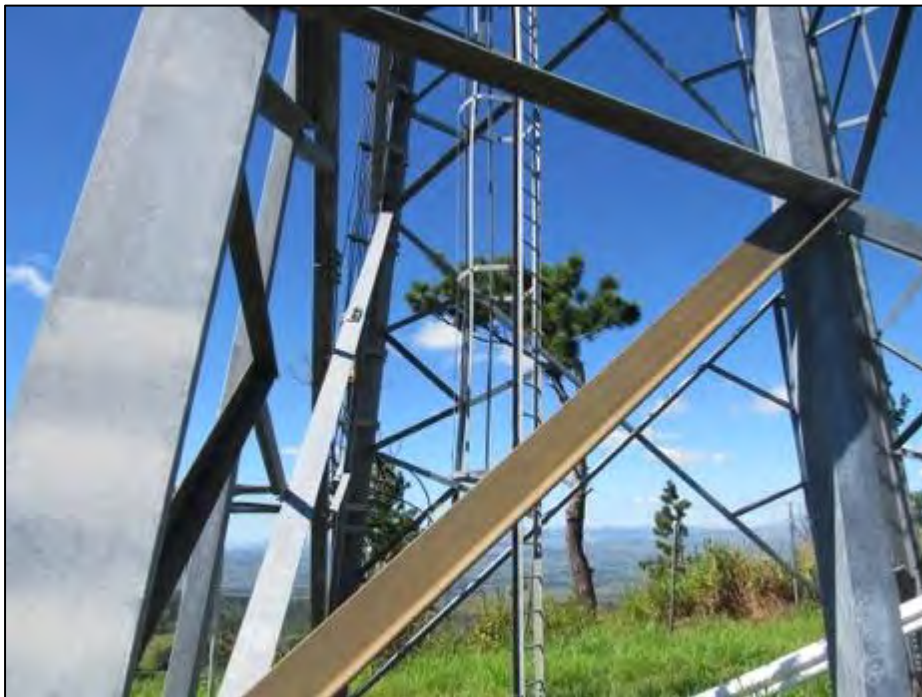
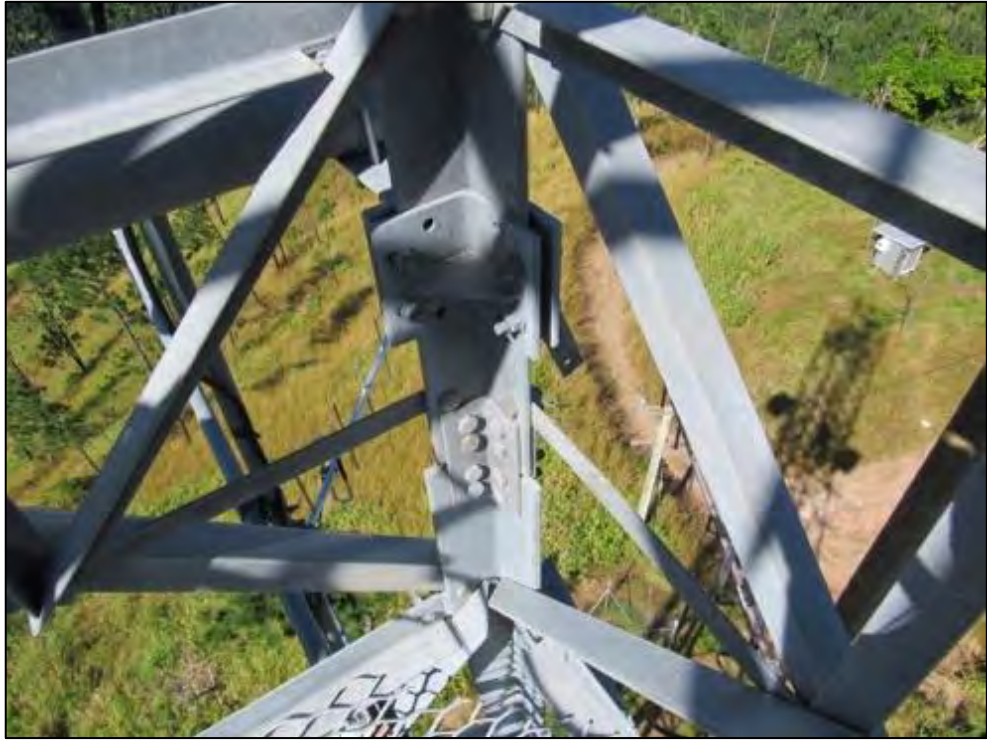
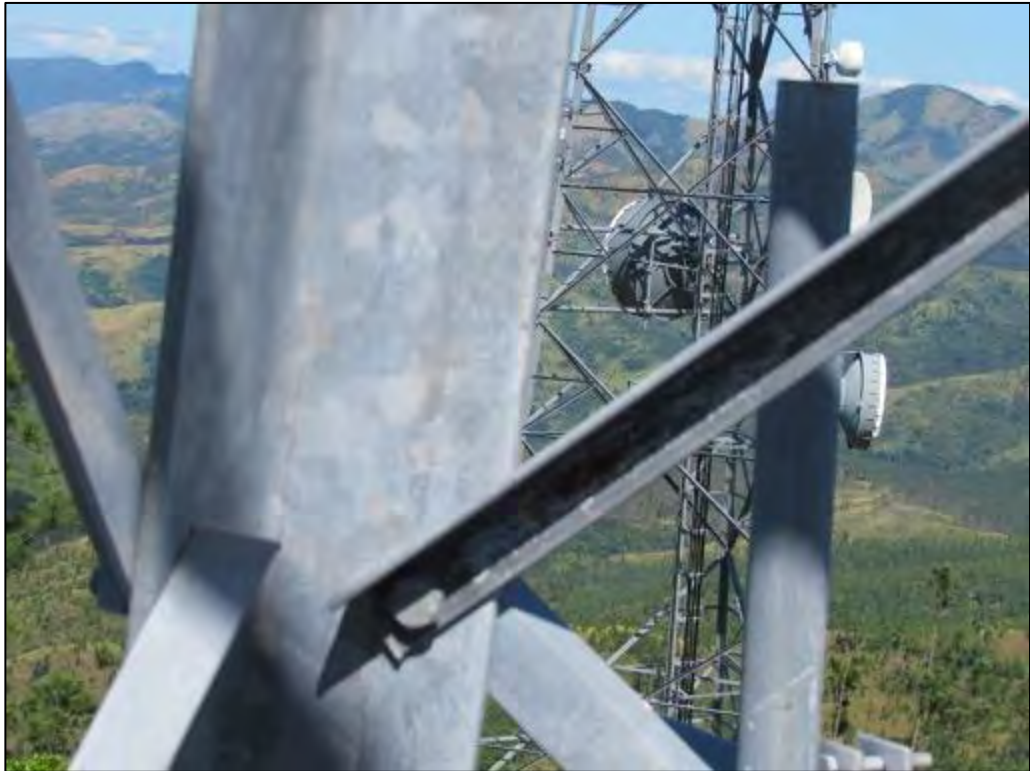
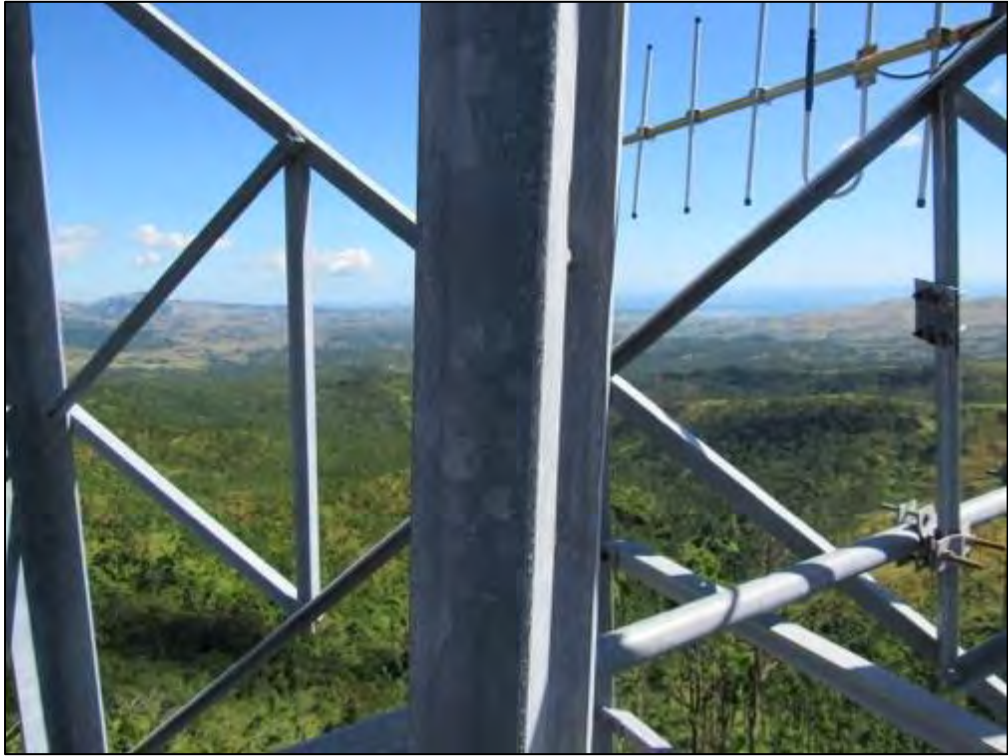
## Tower Images

Tim Greenhill and Wilson Nahi performed a condition assessment on the Navutu tower on the 27<sup>th</sup> May 2017. The tower is in a good overall condition with sound galvanising. The whole structure needs bolt re-torquing as there are a number of loose members. There is rust break out on bolts and nuts and minor alloying on some of the lower members.

It is suggested that apart from some minor bolt replacement, re-torquing of the tower and a review on attached equipment, the tower does not require painting in the near future.

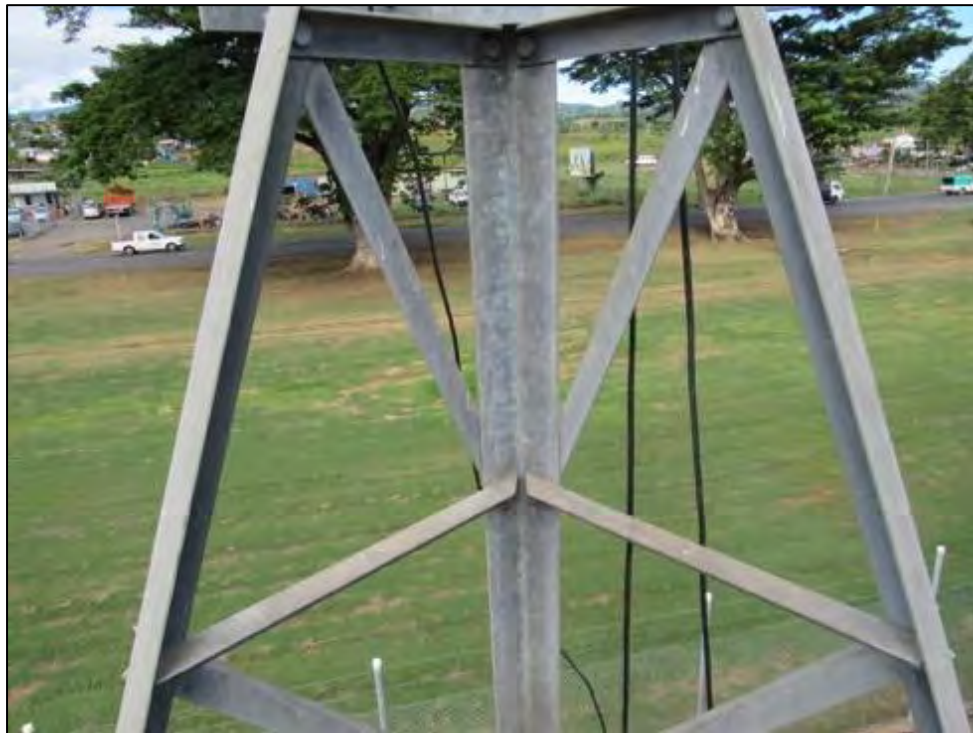
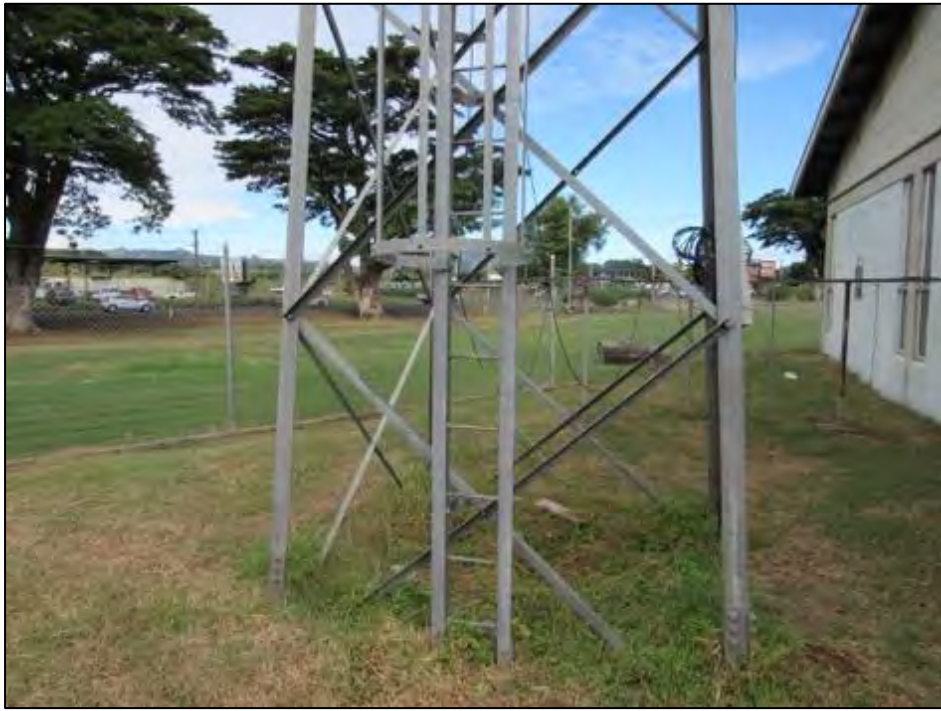
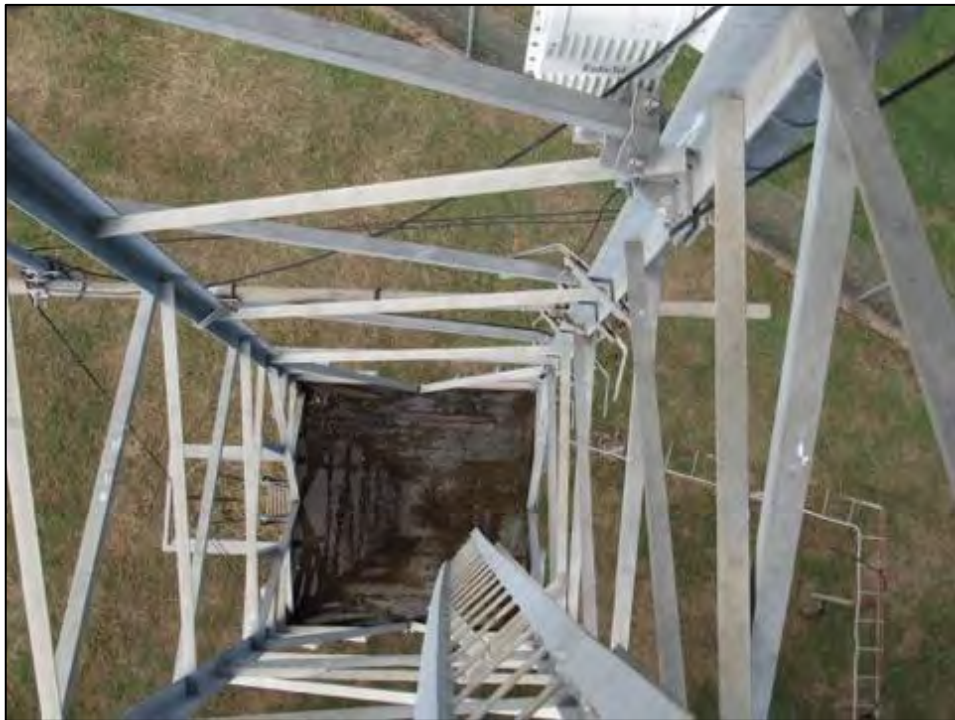
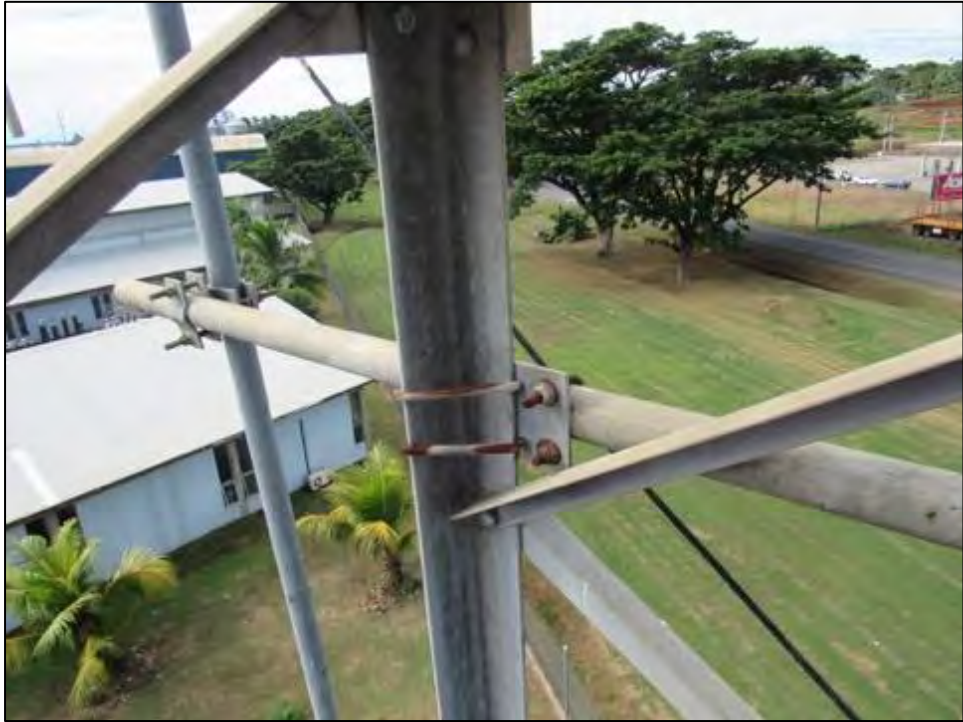
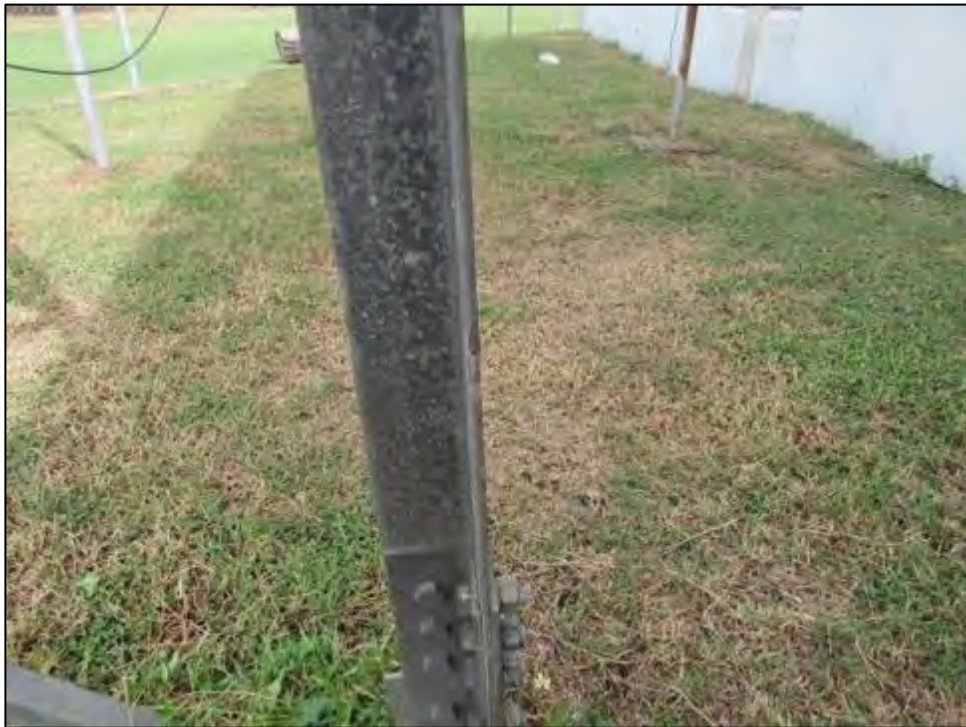
### Tower Images

Wilson and I performed a Condition assessment starting from the ground working our way up the tower. The tower has is in the yard in Latoka and is used only to test gear. The tower has minor rust breaking out on some of the bolts and nuts. Some of the ladder bracket bolts require torqueing as they are loose. 6 brackets holding the UHF aerials need R/C. The top platform of the structure meets R/C criteria it looks added on the structure at some time as it is coated . The tower is in a sound condition with very minor ZCP and a minor amount of rust on it.

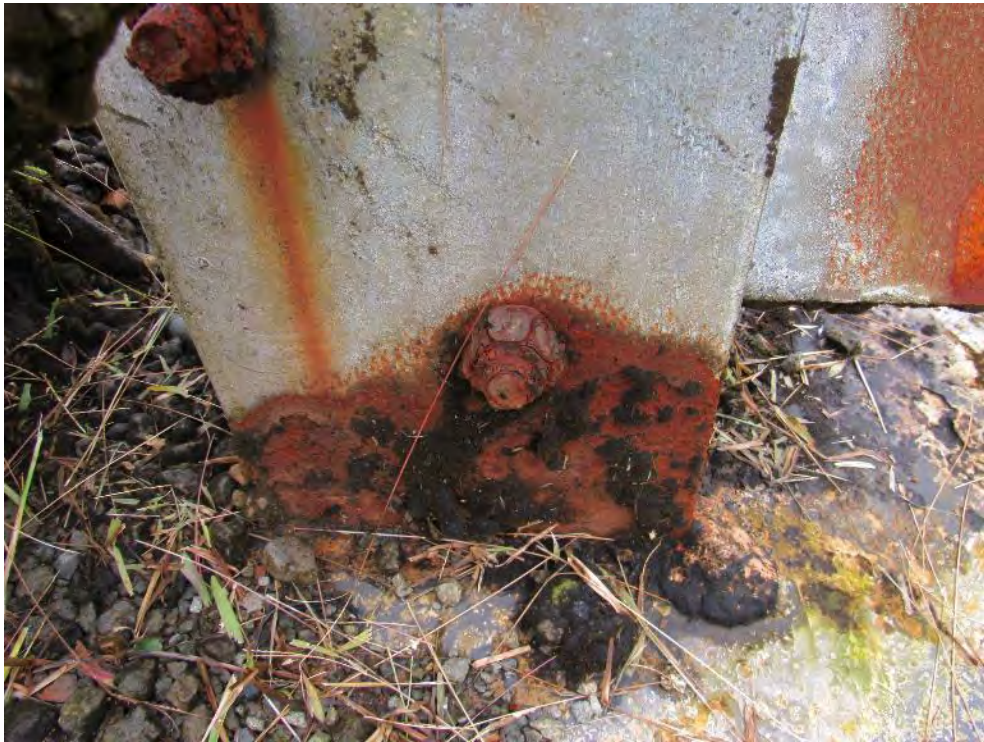
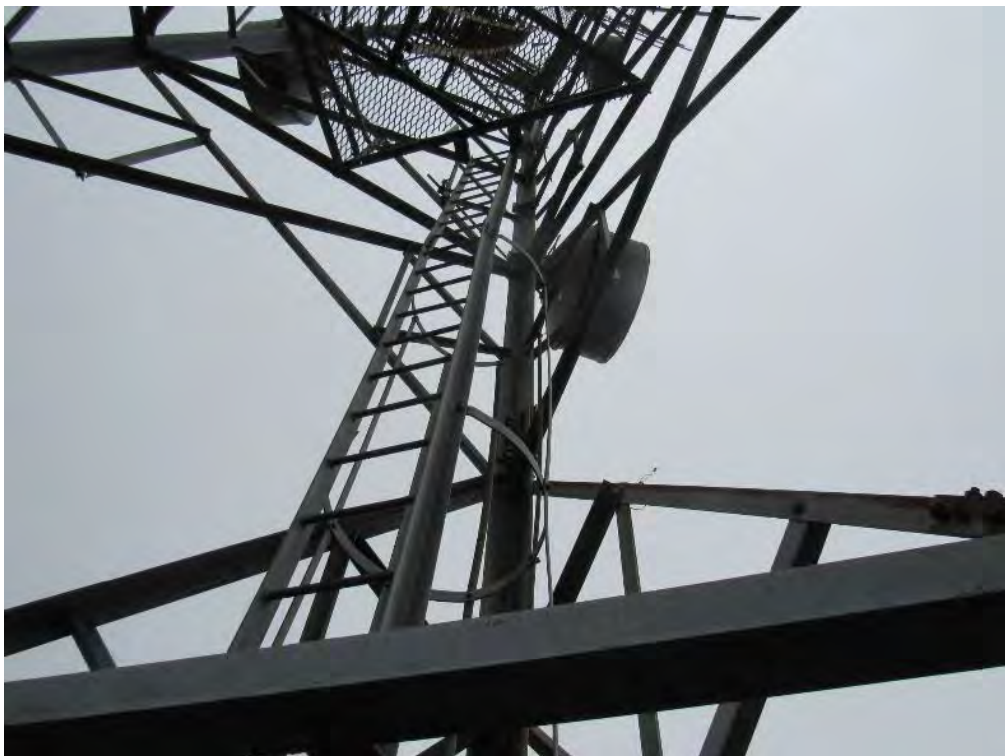
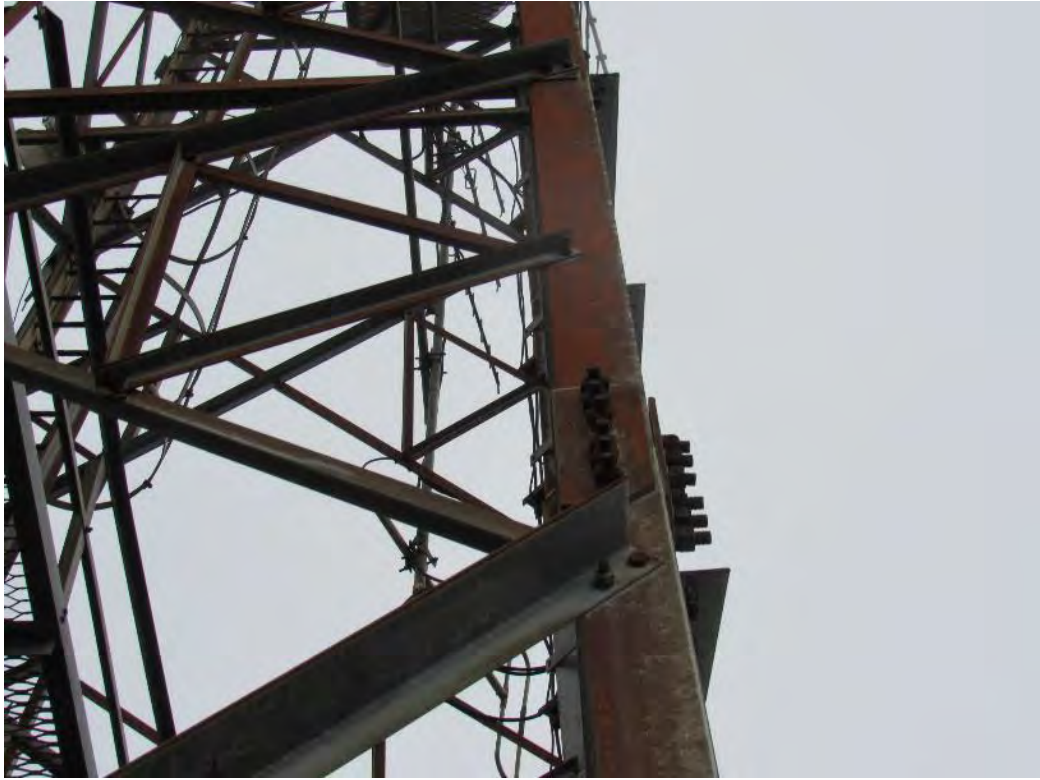
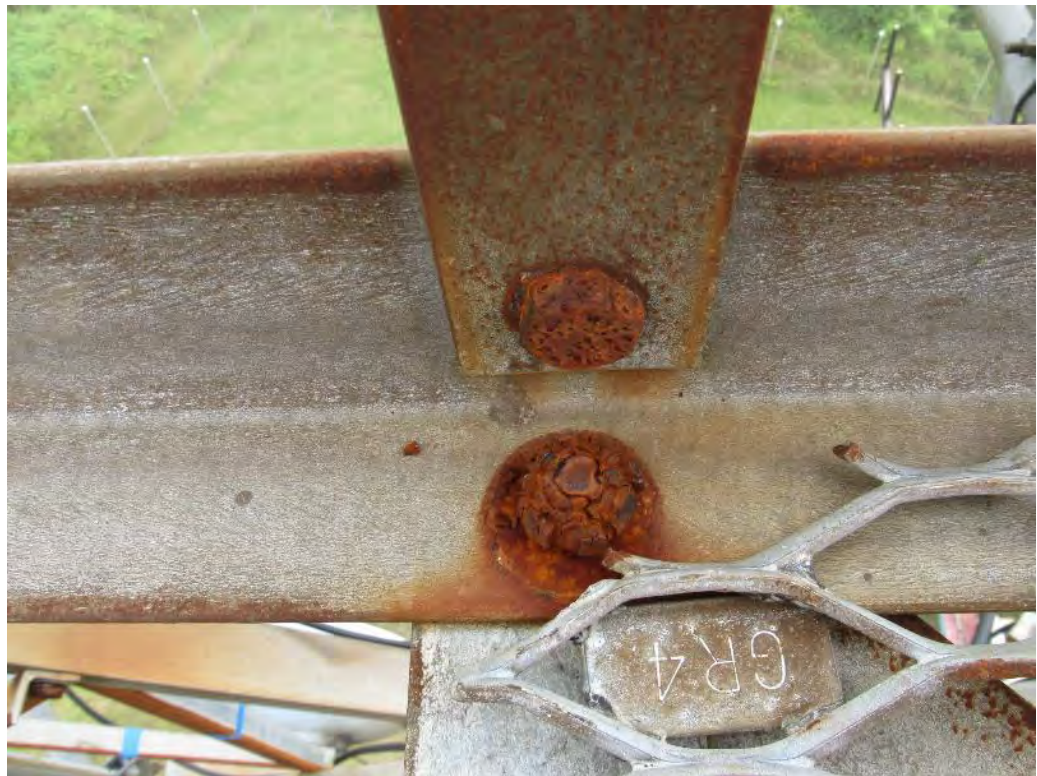
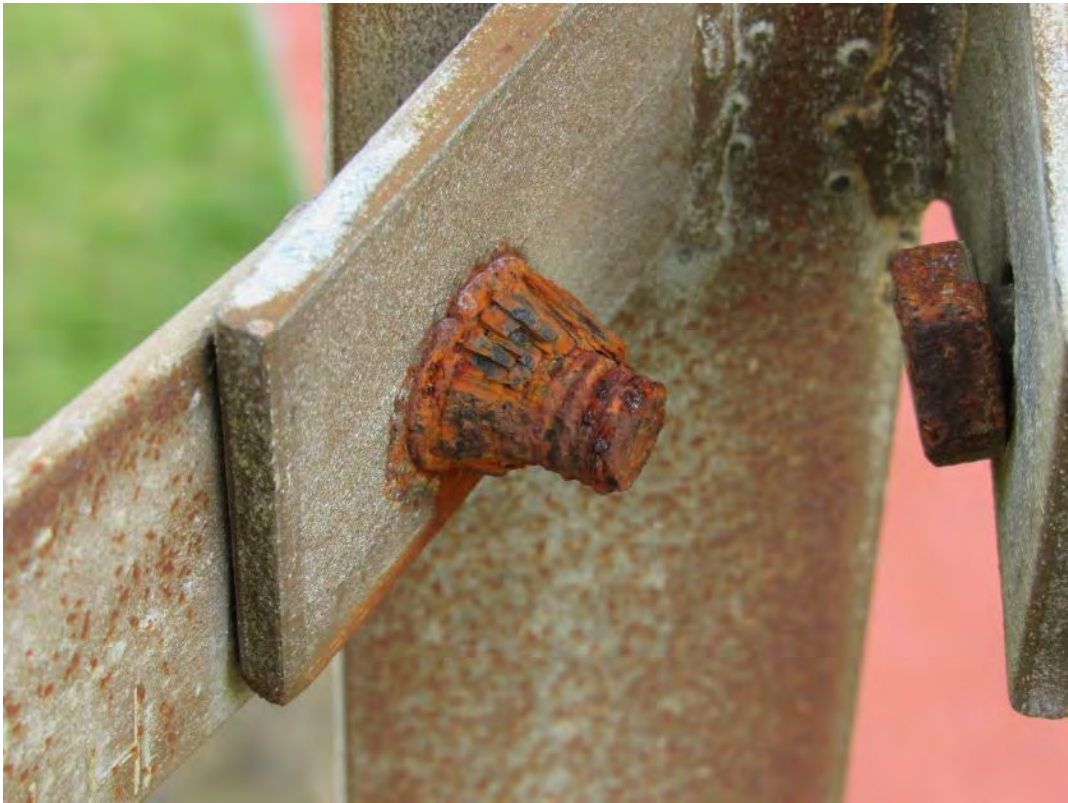
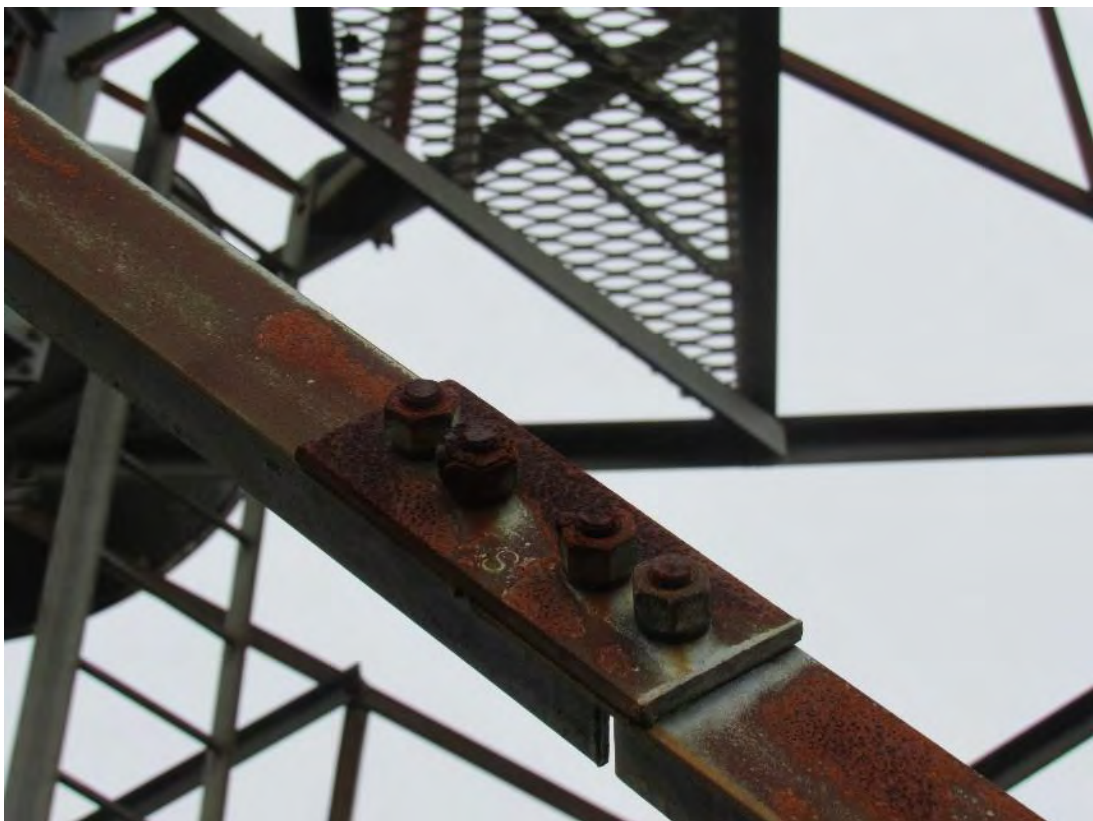
## Tower Images

Type	Red Rust	Alloying (Low Thickness Galvanizing)	ZCP (Zinc Corrosion Product)
Main	13/16	0/16	2/16
Minor	90%	0%	10%

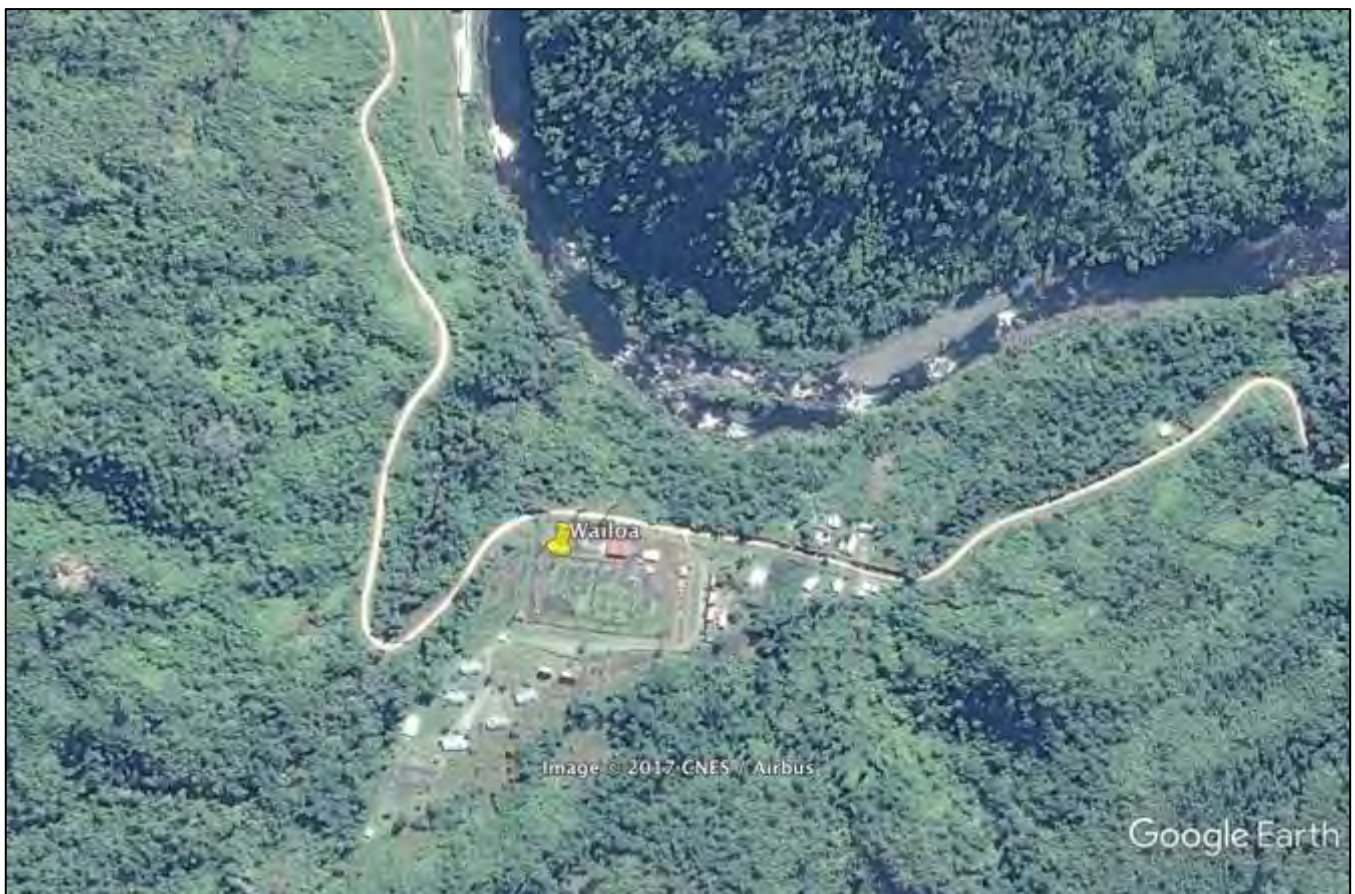
17°44'26.83"S

178°6'8.67"E

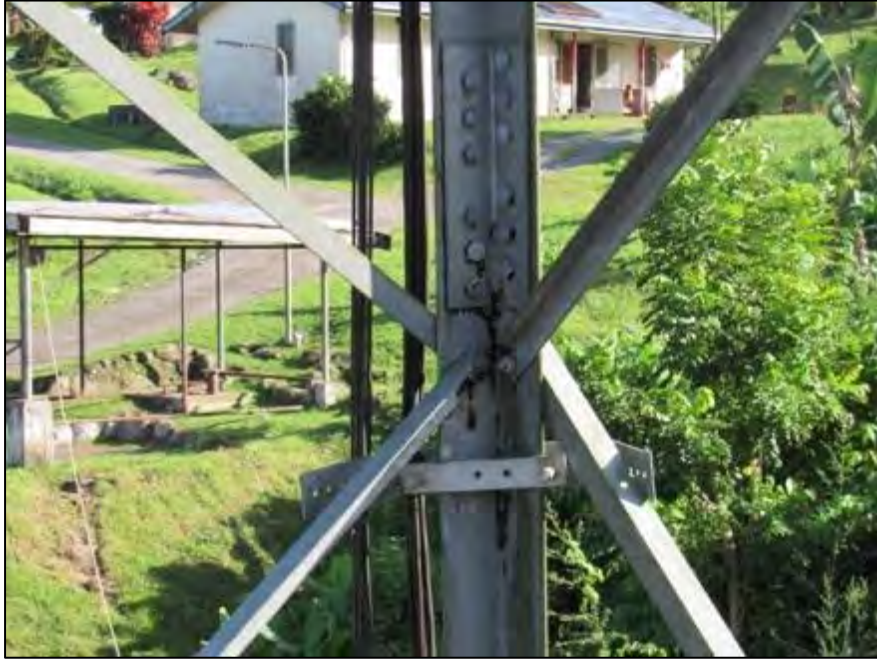
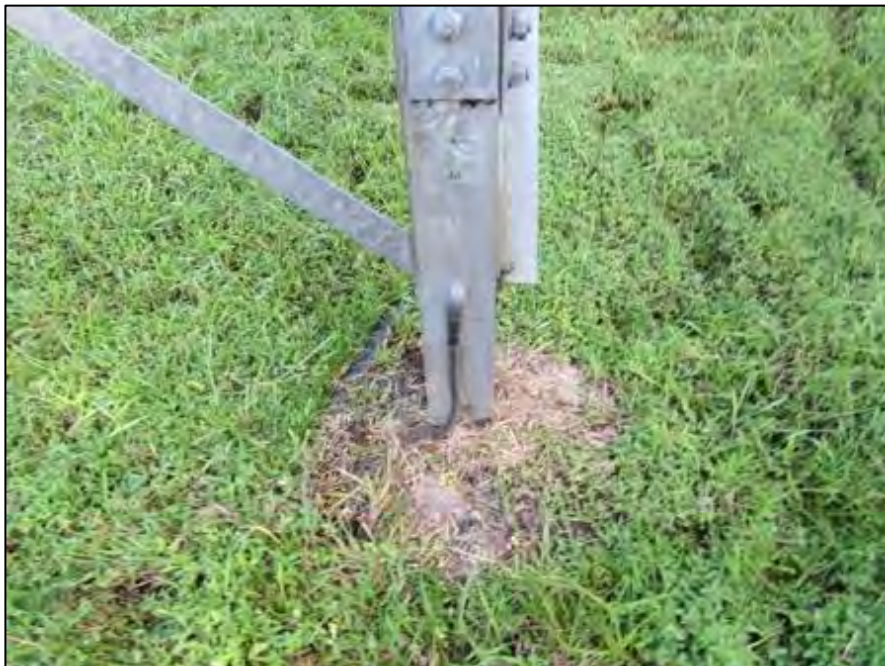
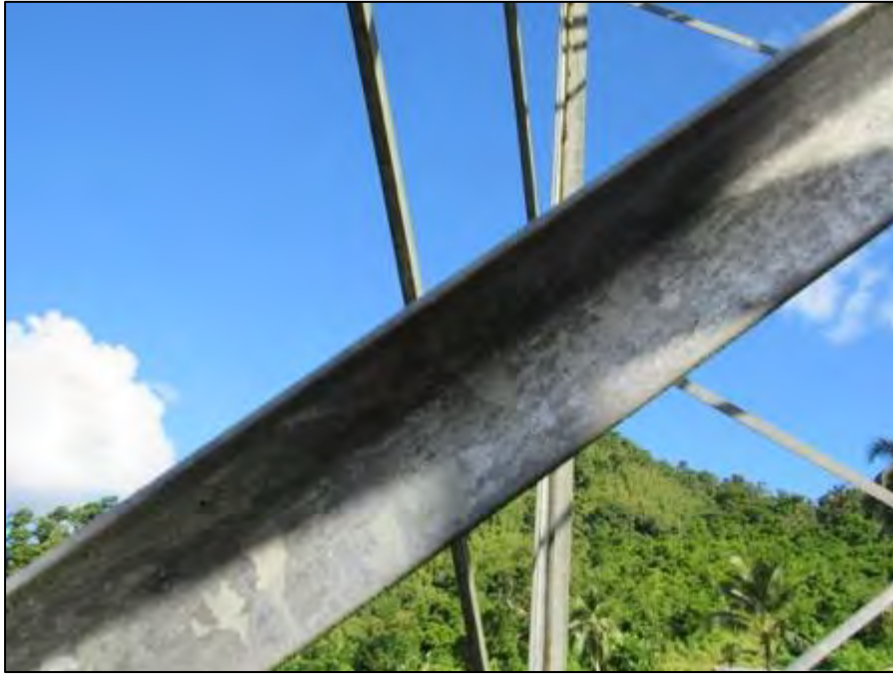
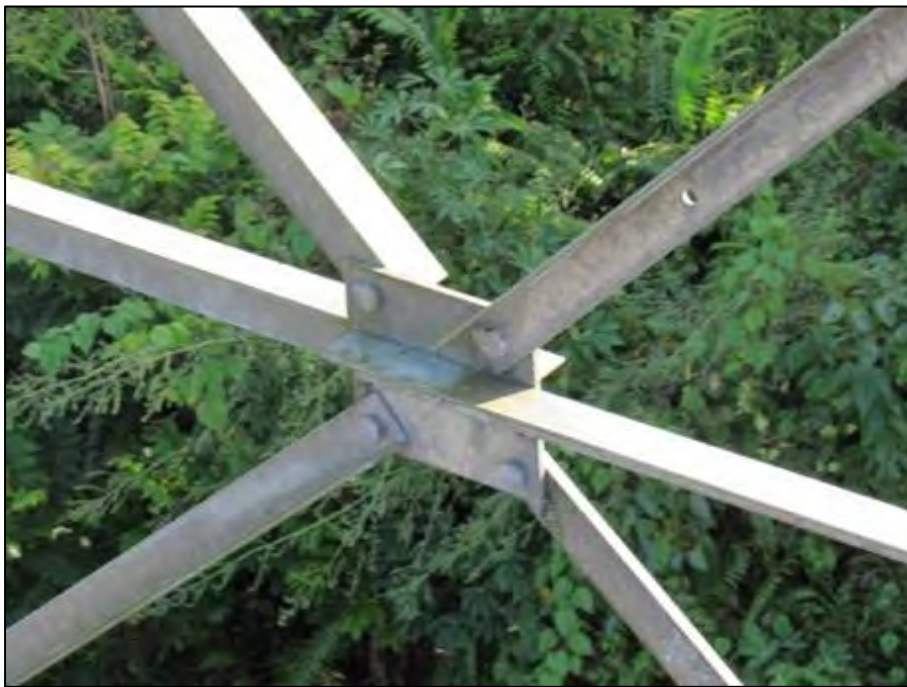
## Tower Images

Some lower diagonal members are loose. Heavy moss and mould on structure

The tower is in sound condition. It is recommended the redundant gear be removed and the whole structure bolts re-torqued. The structure could be water washed light hand prep then coated to prevent corrosion
