FIJI ELECTRICITY AUTHORITY

TENDER NO: MR 04/2017

Upgrading of Existing Perimeter Fence at Waiyevo Power Station, Taveuni.

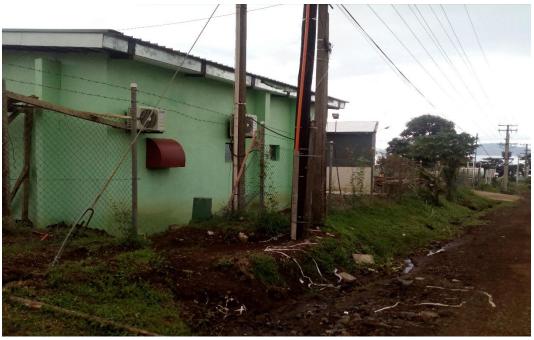
Fig1. Section of fence where chain link is missing

Tighten chain link at loose sections, replace where necessary, No.8 steel wire to run across the whole length of the perimeter at top, middle and bottom sections of the fence. Bottom part of the fence is to be secured to the ground at intervals of 3m to prevent animal entry from the bottom.

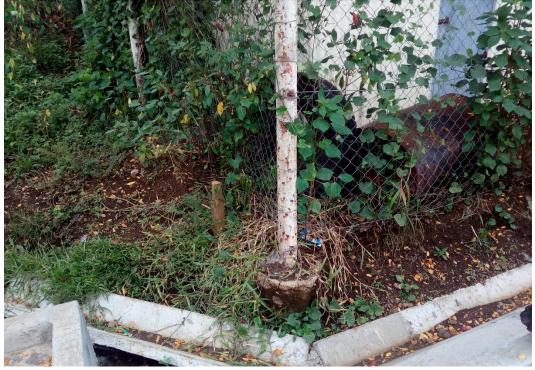
Fig 2. Supporting poles showing rust and concrete setting exposed

Remove rotten posts, replace with new ones, increase stability of all posts (500mm concrete fill for all new posts), and provide additional bracing for poles which are okay material wise but need support structurally. Supporting poles to have cover/caps to prevent water damage.

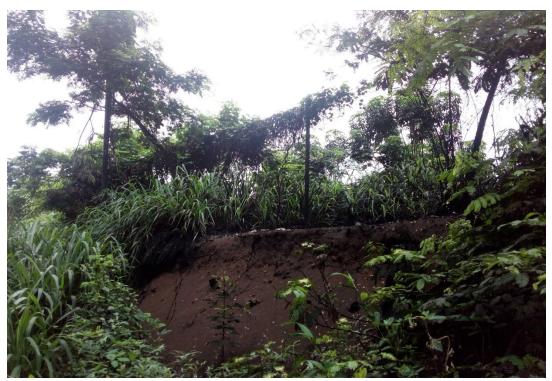
Fig 3. Poor support for poles due to washed away land

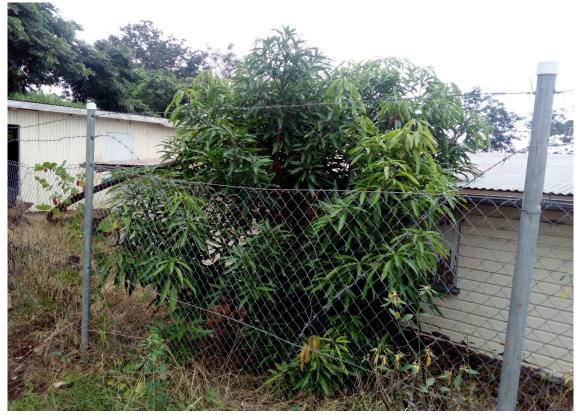
Fig 4. Broken barbed wire

3 rows of barbed wire to be running on top the fence along the entire perimeter. The wires need to be sitting on an angle extension which will need to be fabricated onto all supporting poles. Angle extension to be directed inwards.

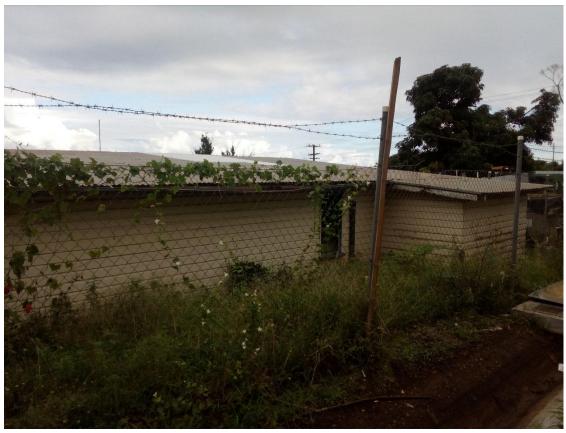
Fig 5. Tangle rows of barbed wire
